The Analysis Report USB-TAP cannot workable problem

Issue date: 2010/10/13

Report date: 2010/12/13

Problem description: There is a few USB-TAP cannot workable in COP RDB

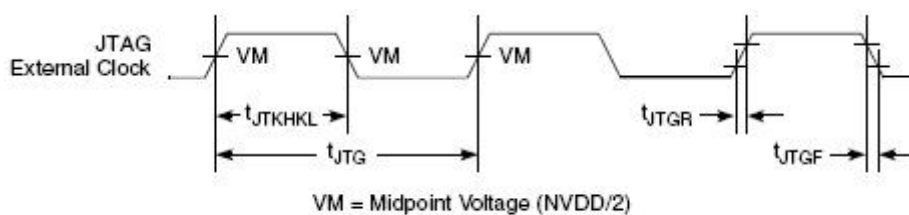
Figure JTAG Clock Input Timing Diagram

1. The Timing Specification

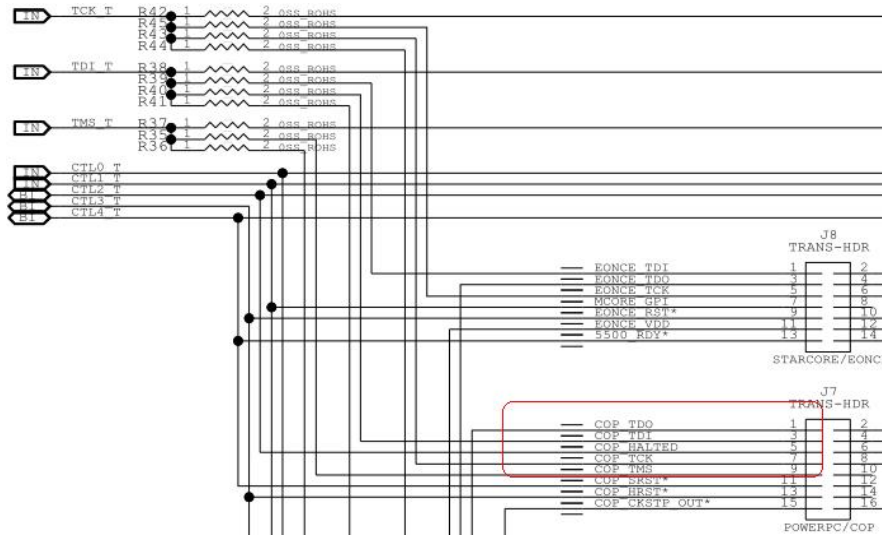
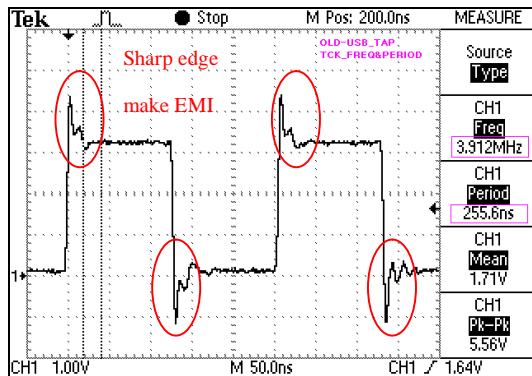
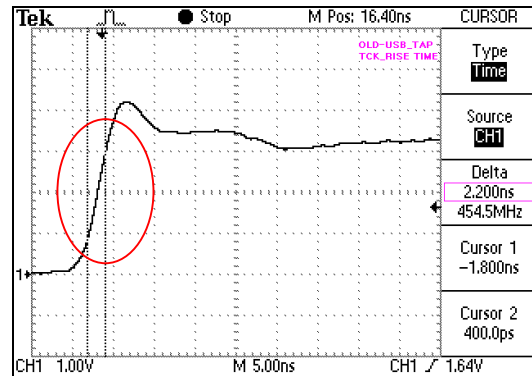
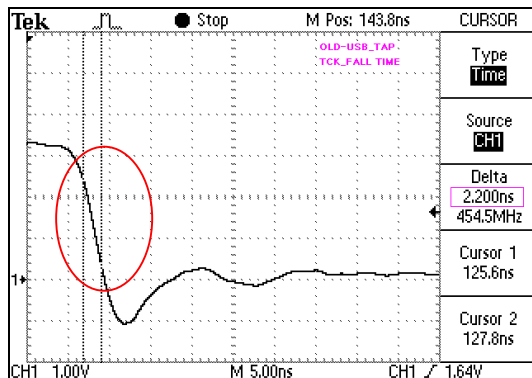
2. Original USB-TAP (Rev.C), no stuff 0.1uF in C118

JTAG timing: $t_{JTG\ R}=2.2\text{ns}$, $t_{JTG\ F}=2.2\text{ns}$ meet spec 2ns (note: probe Tek 116526 has lag)

JTAG Functionality: PASS

EMI in CE/FCC: FAIL

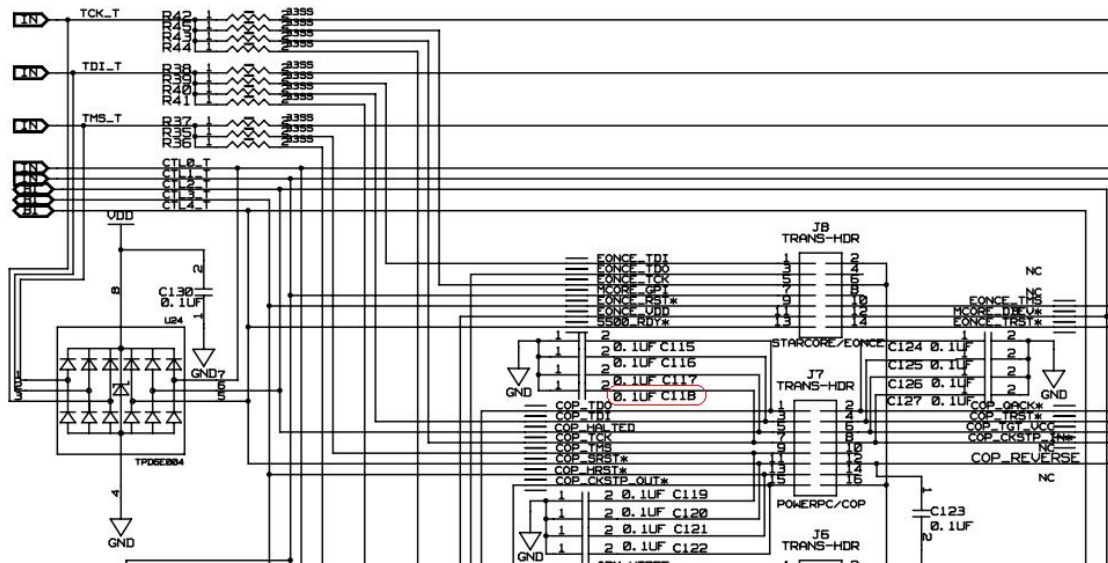
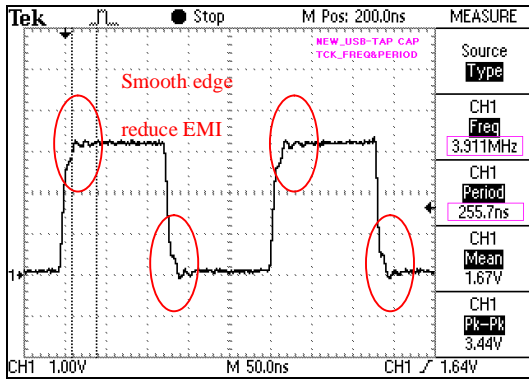
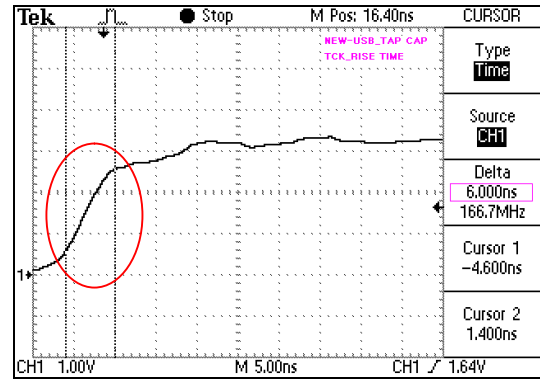
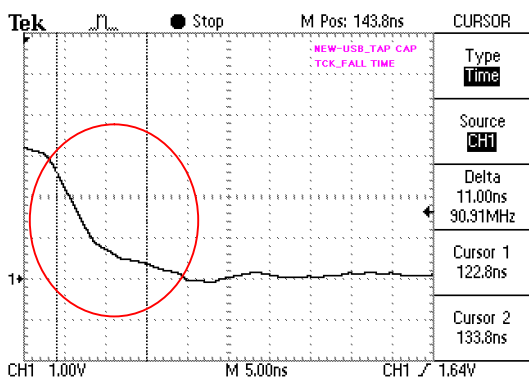
3. NEW USB-TAP (REV.D), C118 stuff 0.1uF

The EMI decoupling capacitor C118 (0.1uF) is too large to slowdown the falling time of TCK (JTAG signal). It makes the setup and hold time over IEEE1149.1 specification.

JTAG timing: $t_{JTAGR}=6ns$, $t_{JTAGF}=11ns$ over spec $2ns$ (note: probe Tek 116526 has lag)

JTAG Functionality: Some models are fail

EMI in CE/FCC: PASS
