# i.MX 6UL EVK VDD\_ARM\_SOC\_IN Overshoot Issue

Leo Pan

May, 2017

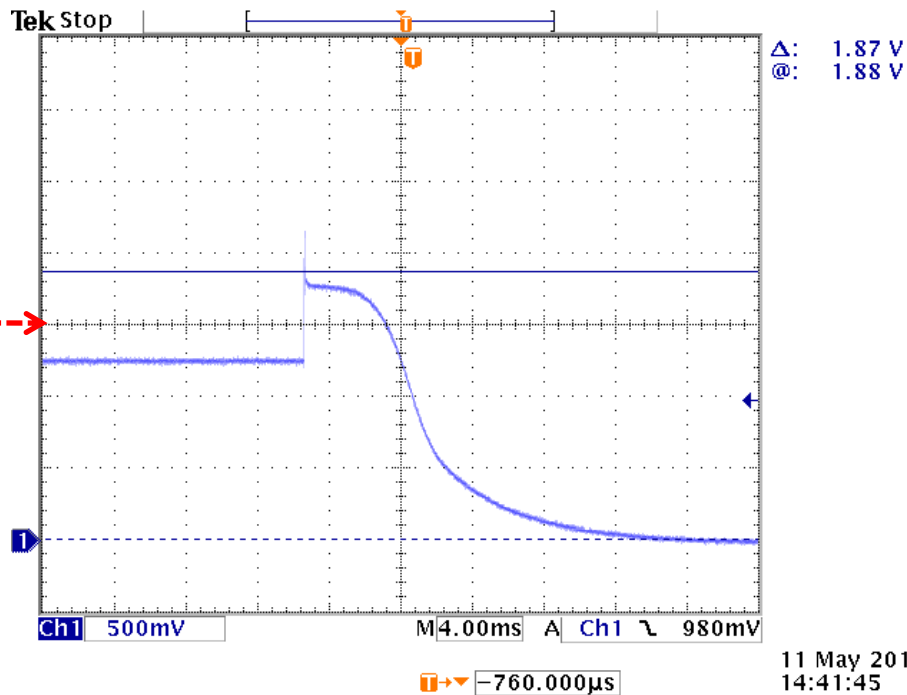
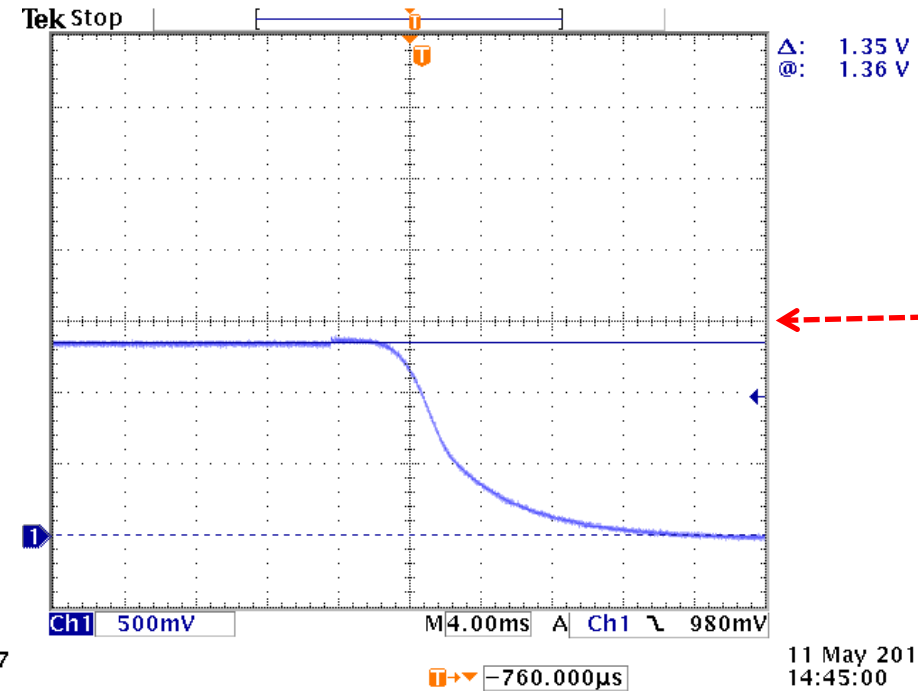
- **Board:** MCIMX6G2CVM EVK Board (SPF-28617)
- **Issue Description:**
  - Overshoot ( $> 1.8\text{V}$ ) is found on VDD\_ARM\_SOC\_IN when the EVK board is powered down by POWER BUTTON long pressed after the Linux kernel loaded. It would not happen if only U-Boot is run. The overshoot is out of i.MX6UL maximum rating.

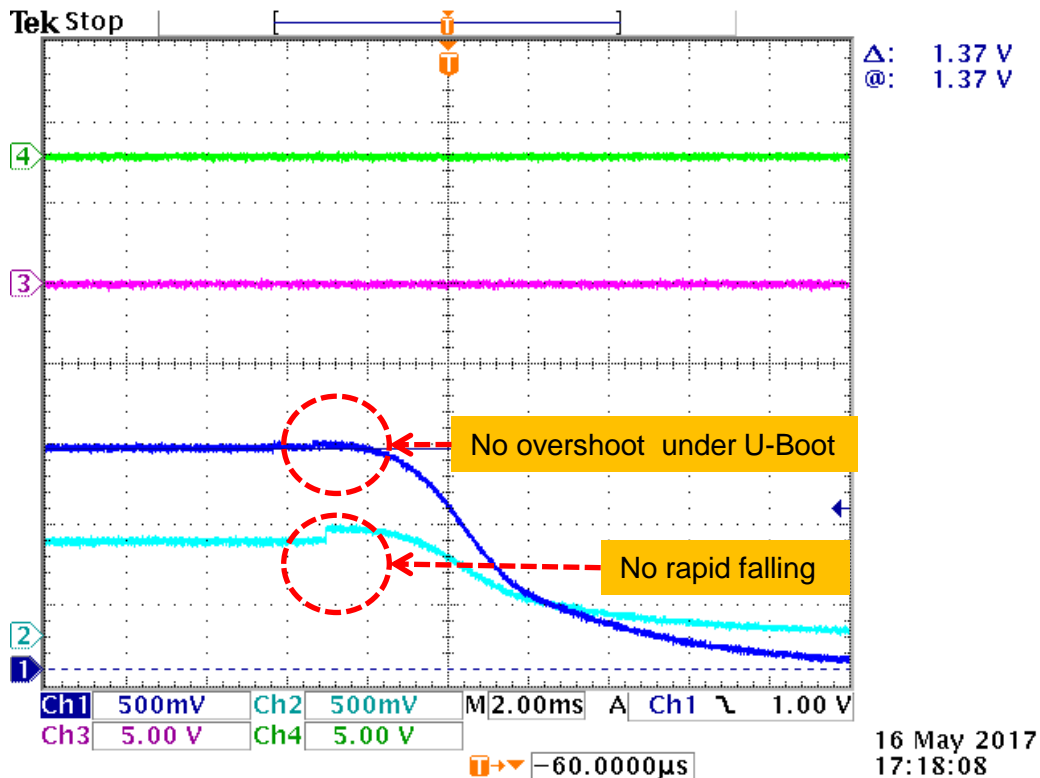
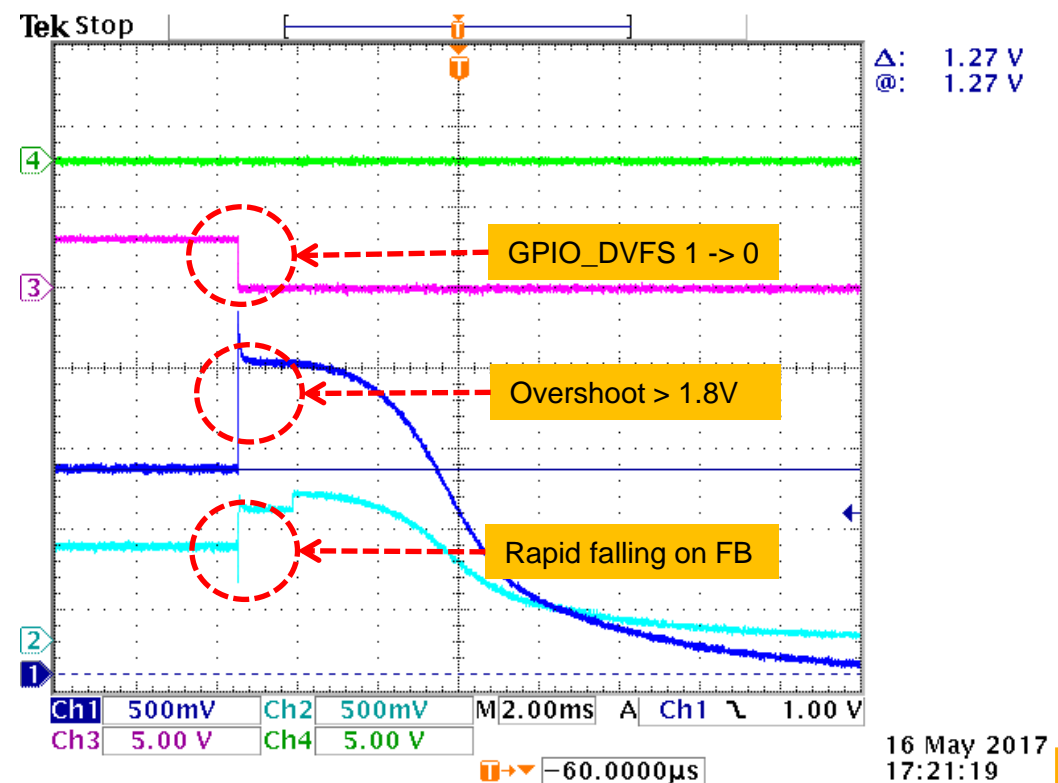
- VDD\_ARM\_SOC\_IN output voltage is (1.37V@PMIC\_STBY\_REQ = 0, GPIO\_DVFS = 0) under U-Boot.
- VDD\_ARM\_SOC\_IN output voltage is (1.27V@PMIC\_STBY\_REQ = 0, GPIO\_DVFS = 1) when Linux kernel is run.
- When GPIO\_DVFS is changed from 1 to 0, overshoot happens because of rapid falling on FB.

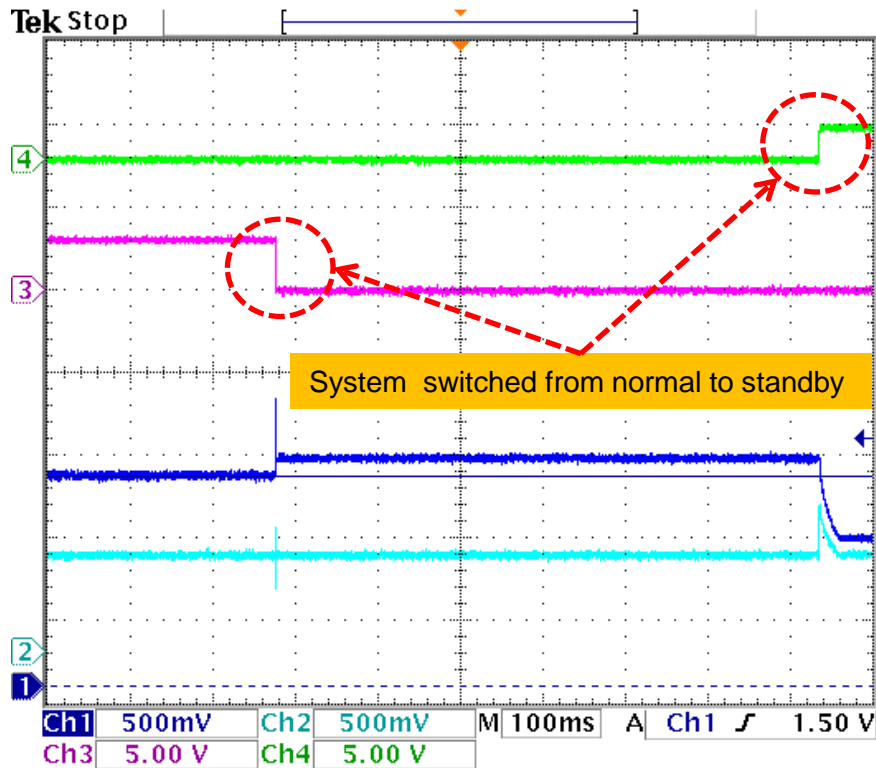
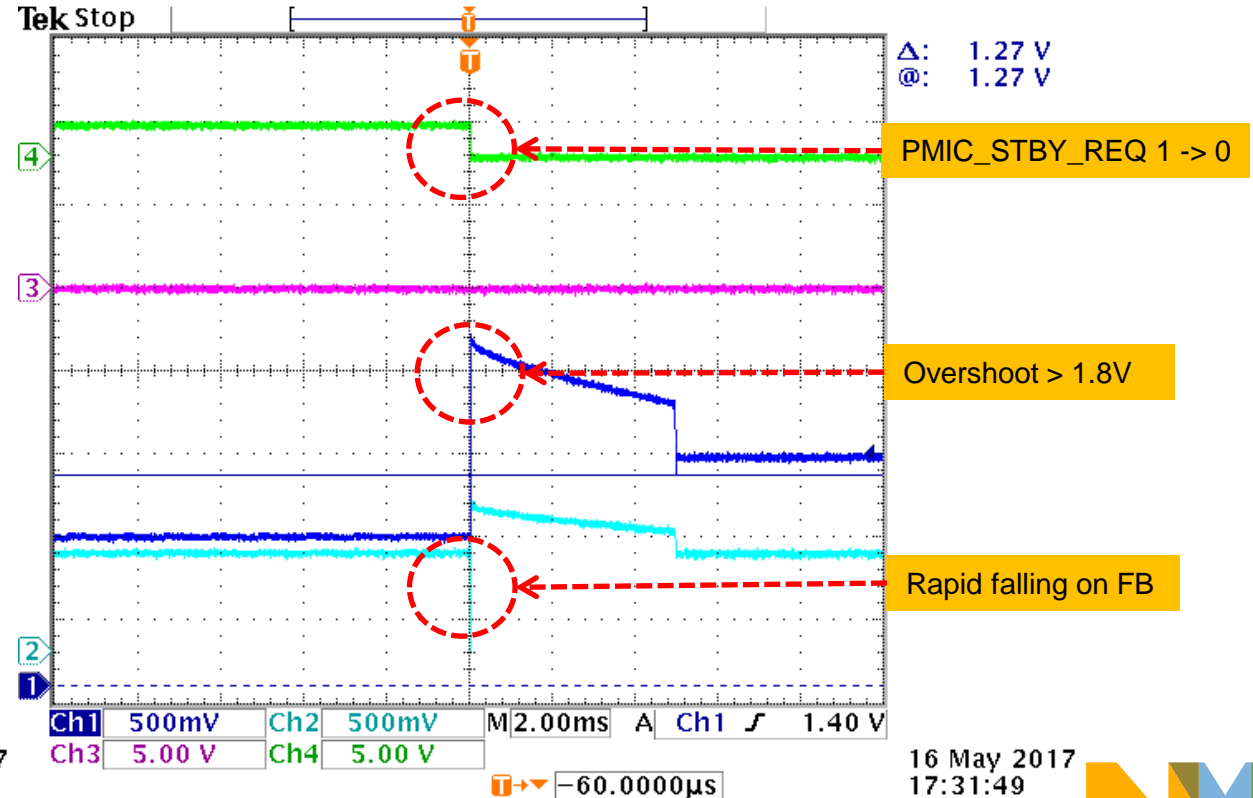
- VDD\_ARM\_SOC\_IN output voltage is (1.37V@PMIC\_STBY\_REQ = 0, GPIO\_DVFS = 0) under U-Boot.
- VDD\_ARM\_SOC\_IN output voltage is (0.93V@PMIC\_STBY\_REQ = 1, GPIO\_DVFS = 0) when the system is standby.
- When PMIC\_STBY\_REQ is changed from 1 to 0, overshoot happens also because of rapid falling on FB.

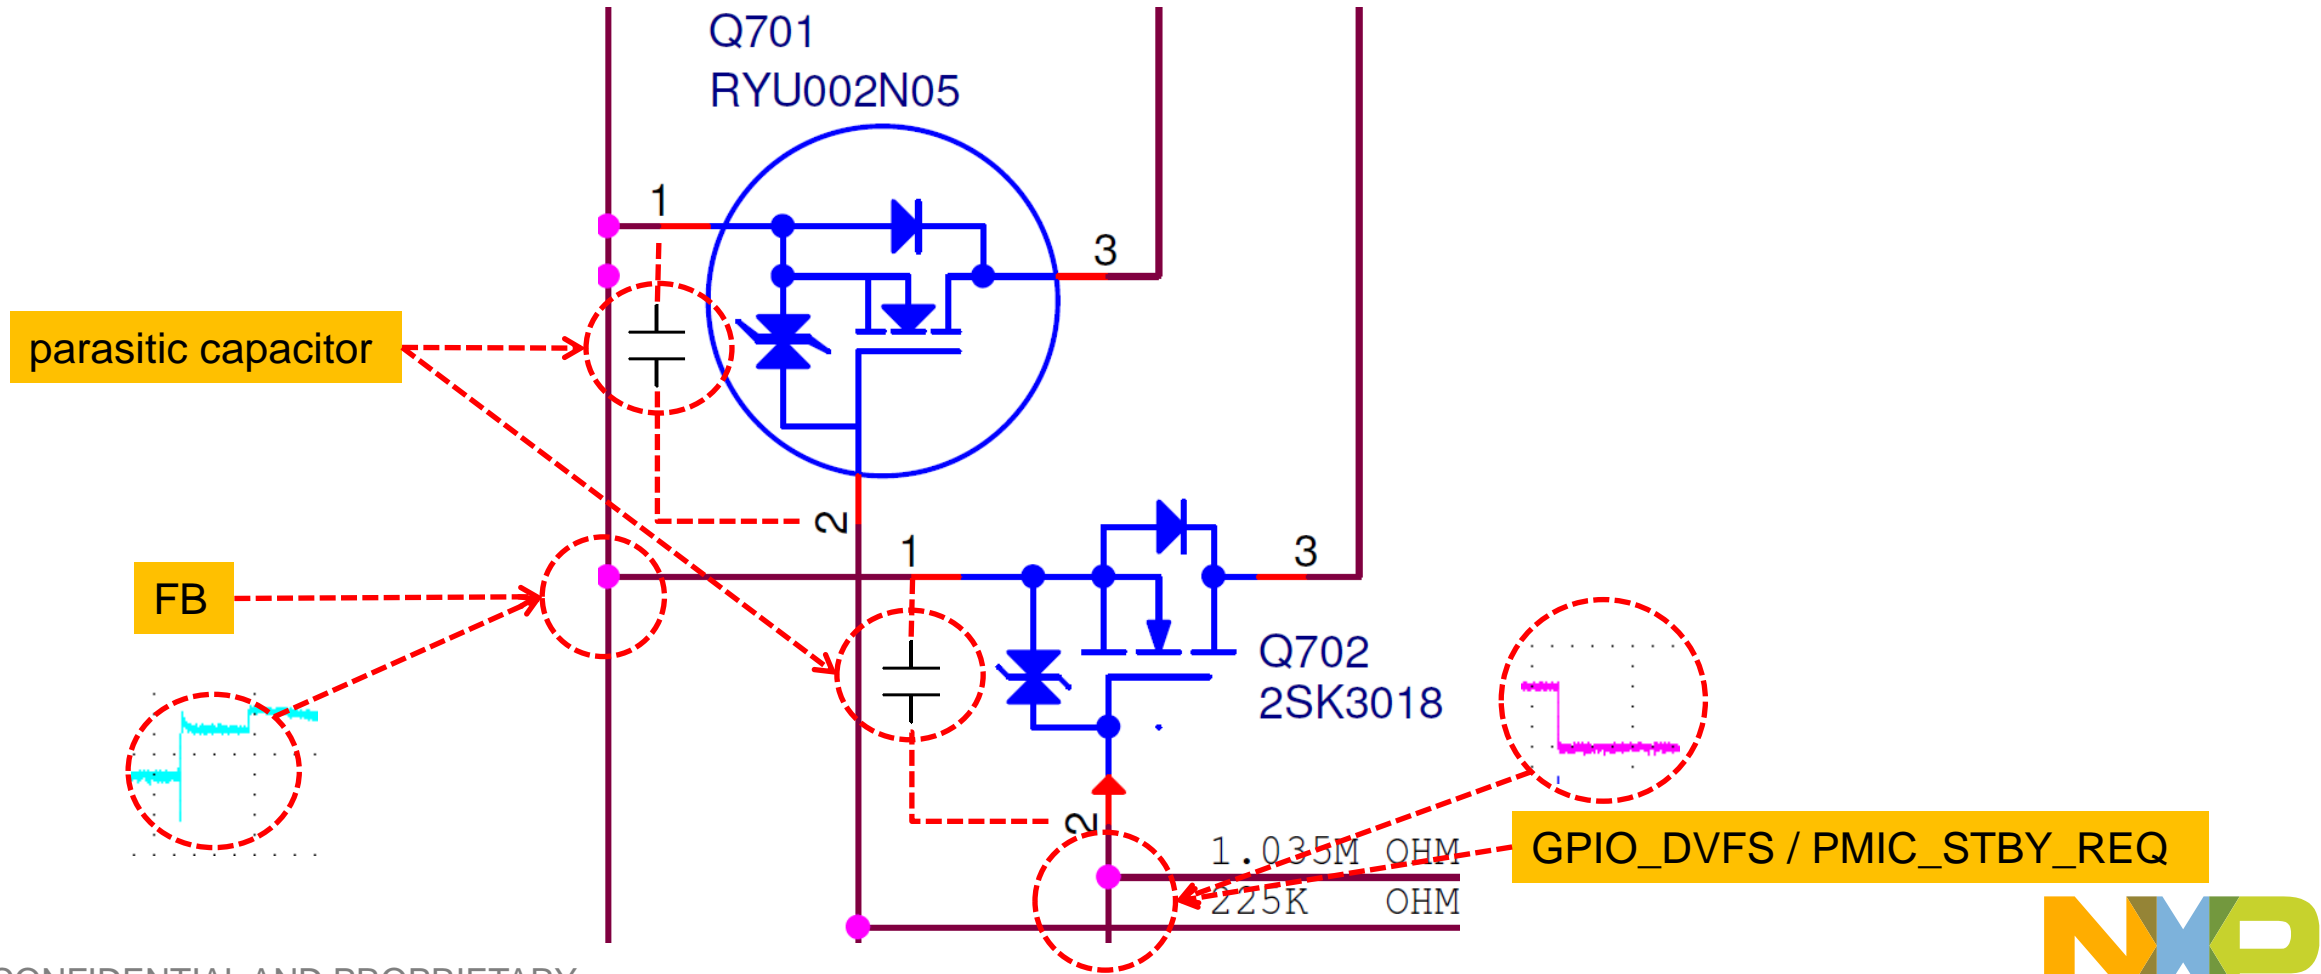
Rapid falling (1 -> 0) of GPIO\_DVFS/PMIC\_STBY\_REQ will be coupled to FB via the parasitic capacitor between Gate pin and Source pin of the N-FET and cause the overshoot on VDD\_ARM\_SOC\_IN.

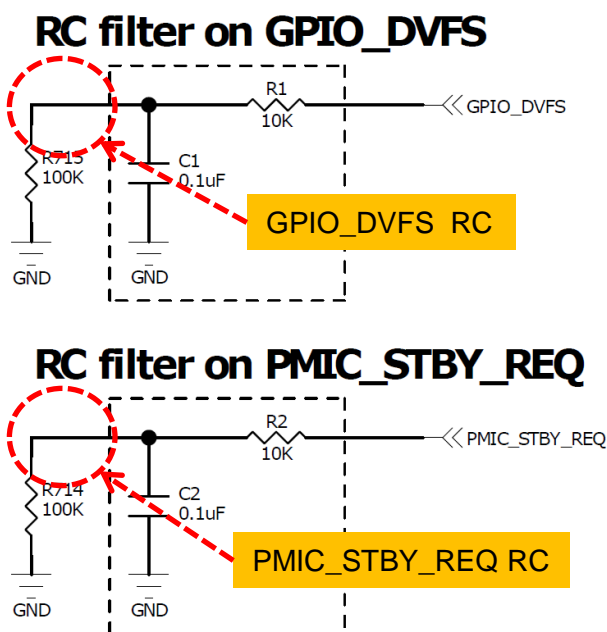
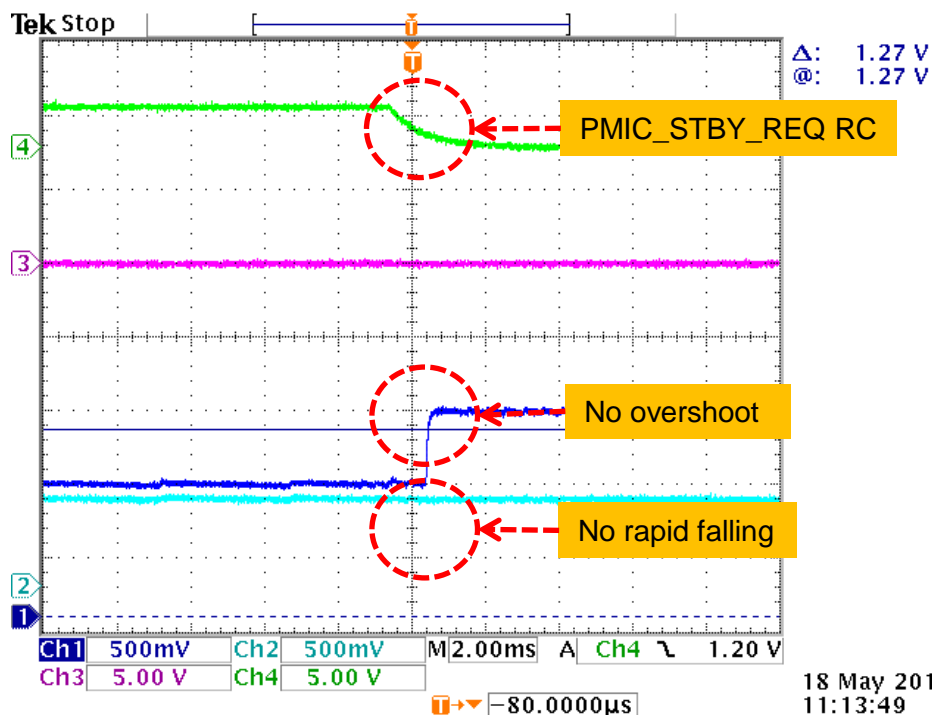
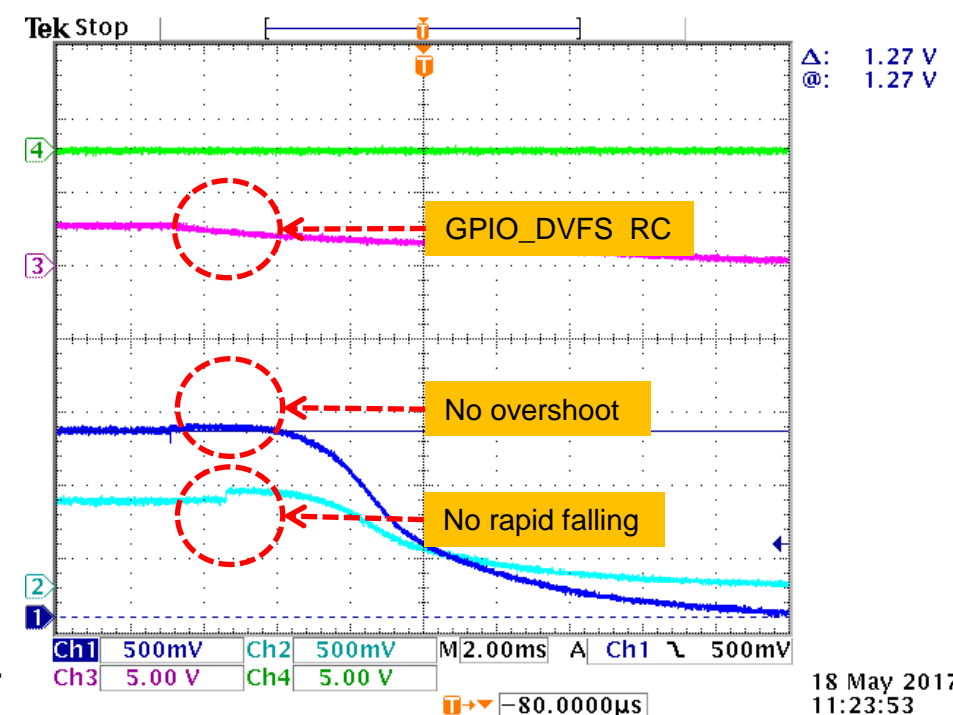
With this RC filter, VDD\_ARM\_SOC\_IN needs more time to recover its output level, hence it might need one more millisecond additional delay in software.

Add RC filter on the Gate pin of the N-FET to eliminate the rapid falling on it.
