Chip Errata for the i.MX23

This document details all known silicon errata for the i.MX23. [Table 1](#) provides a revision history for this document.

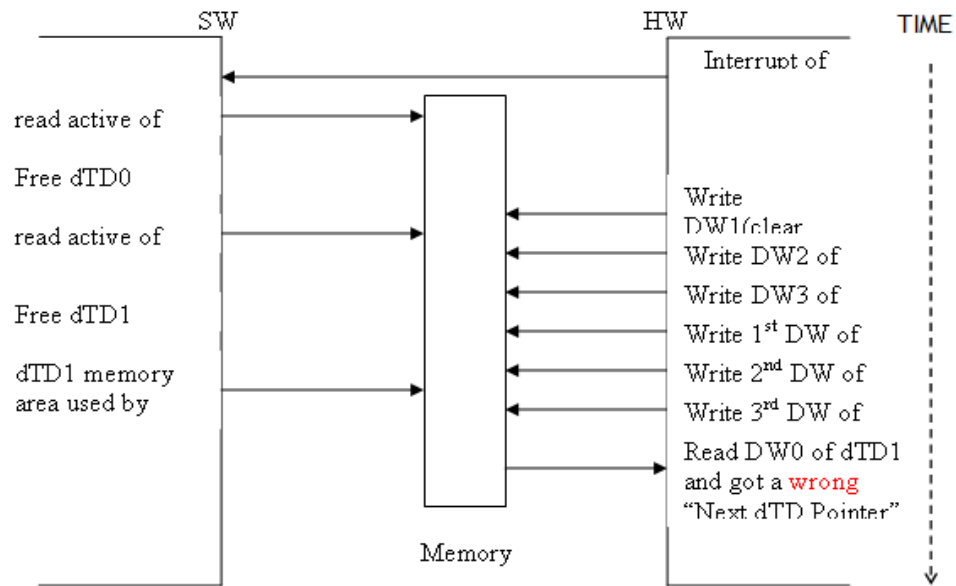
Figure 1. dTD Issue Sequence of Events

USB controller may access a wrong address for the dTD (endpoint transfer descriptor) and then hang.**Description:**

After step 1, if software finds the Active bit is cleared, then the dTD memory space is freed and this space may be allocated for other thread use. In step 3, hardware may get a wrong dTD.

This issue does not occur if some delay is added before freeing the dTD memory space.

This issue only occurs in USB INCR8 mode, because steps 1 and 2 have 6 SINGLE AHB transfers in INC8 mode, but only 2 burst AHB transfers in INCR mode.

This issue only occurs when the dTD list is used, because if only one dTD is used, the software only checks the Active bit after an interrupt is received (step 3). But when the dTD list is used, the software may check the entire list after the interrupt for the first dTD is received, and hardware just finished the transfer of the second dTD at this time.

Postpone freeing the current dTD; free it when its next dTD can be freed, so the last completed dTD (followed by an ACTIVE dTD) is always freed when the next IOC irq comes.
