i.MX6Solo ESAI TDM slot issue (1/)

- Overview
 - The TX output data slot location could be misaligned when ESAI_TX(RX)_CLK frequency is higher than 20.8MHz.
- The customer's setting
 - The customer's system is as Figure-1.

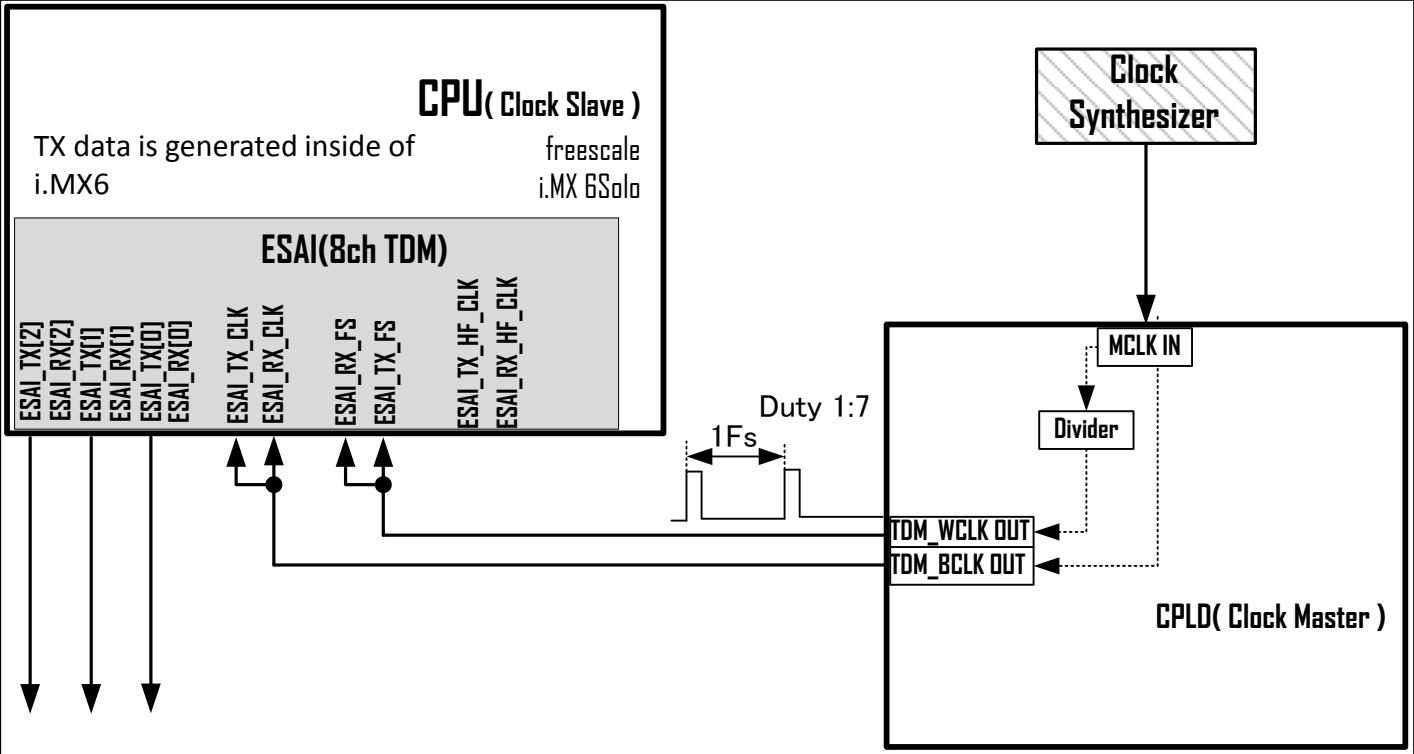
Figure-1

- They use i.MX6S ESAI for 96KHz TDM 8ch output.
 - In this condition, ESAI_TX_CLK and ESAI_RX_CLK should be 24.576MHz.
 - i.MX6S ESAI is used as clock slave and the clock is provided from external. HF_CLK is not provided.

- TX data is generated internally and transferred using DMA.
 - This phenomenon can be seen also in the case that ESAI_TX_CLK and ESAI_RX_CLK are generated internally.

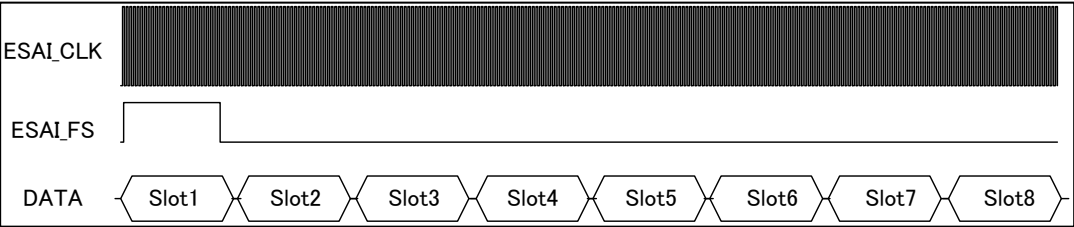
Figure-2 8 slots TDM data

- ESAI is used as 8slot TDM. (Figure-2)
 - Polarity settings for each clock: Rising Edge
 - They tried Falling Edge setting, but the phenomenon came to be worse.

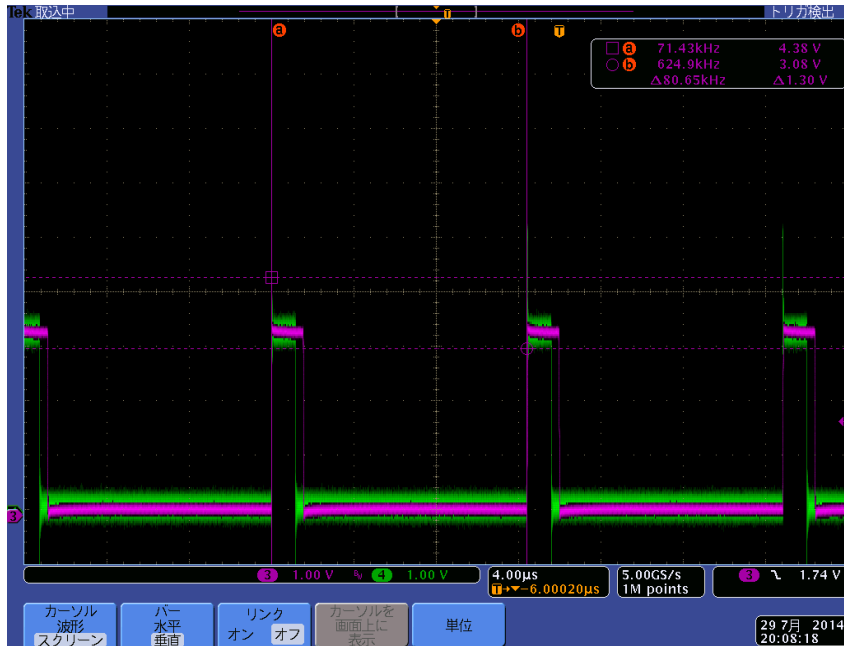
Figure-5 Expected behavior

- Phenomenon
 - For the test, the data of slot1 TX is set to 0xFFFFFFFF00 and the data of other slots are set to 0 inside of i.MX6S in order to monitor the waveform of the slot data easily.

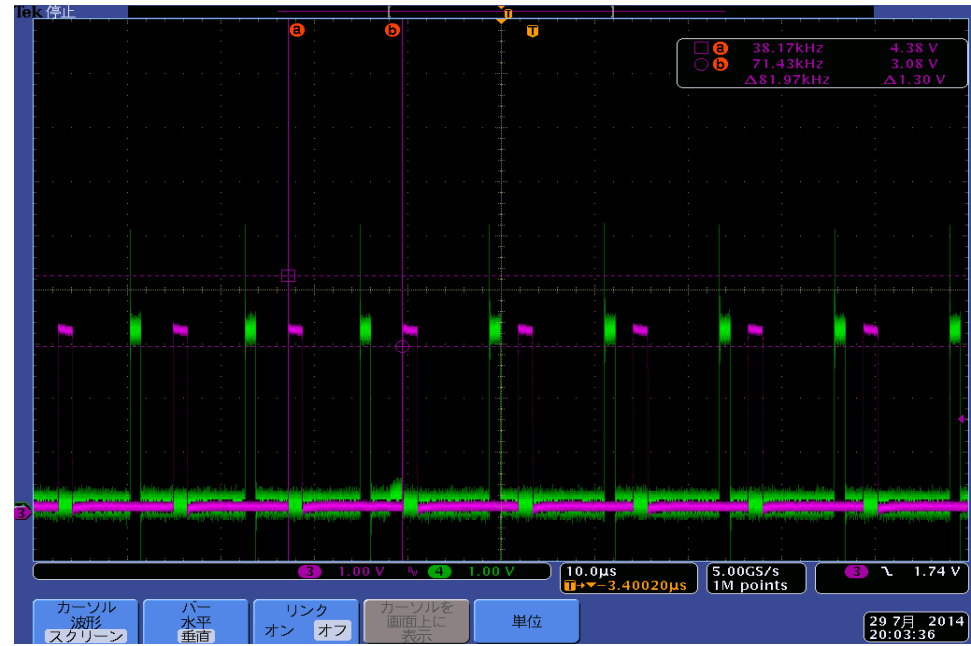
Figure-6 slot location misalignment

- In above situation, the TX output from i.MX6S should be as Figure-5.
 - The slot misalignment could be seen in the customer's lab. (Figure-6)
 - Figure-6 shows that the slot1 data location is misaligned.

- The customer tested if the issue can occur with various ESAI_TX(RX)_CLK frequencies. As the result, they found that the issue could occur only when the frequency of ESAI_TX(RX)_CLK input is higher than 20.8MHz.

- In the case of lower ESAI_TX(RX)_CLK frequency than 20.8MHz, the issue does not occur.
 - For the test, they tried with 198MHz of ahb_root_clk (CBCDR[AHB_PODF] divisor = 1/2). In this case, the issue did not occur even when the ESAI_TX(RX)_CLK is higher than 20.8MHz. From this test, the quality of ESAI_TX(RX)_CLK signal generated externally seems to be OK.
