Problem Analysis and solutions for booting from ROM BOOTLOADER in KL series

1 Abstract

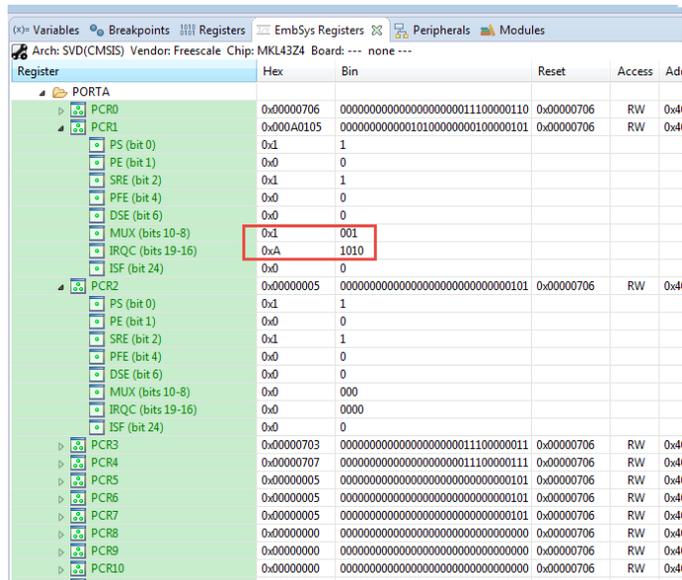
Checking the PORTA register before do the cpu and peripheral initialization, PTA1 is enabled the port interrupt, and choose Flag and Interrupt on falling-edge.

This can tell us why the PTA1 pin have the problem of uart receive data or give a falling edge in PTA1 will run abnormal, because in default, even we configure the PTA1 as the uart receive function, but the code didn't clear IRQ and NVIC register, when the signal happens on PTA1 pin, it will caused the PORTA interrupt, but we didn't add the PORTA interrupt ISR function, it is also not useful to us, then PC don't know where to go, so it will run abnormal, enter the defaultISR, and can't recover. If you have interest, you can add the PORTA_IRQHandler function, you will find the code will run to this function.

So, if customer want to solve this problem, to avoid the application enter to the abnormal area, we can disable the NVIC in the application code like this, the I2C NVIC is the same:

```
NVIC_DisableIRQ(8); //disable I2C0 interrupt
NVIC_DisableIRQ(30); //disable PTA interrupt
```

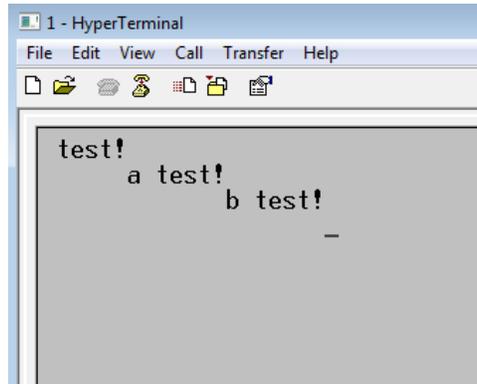
3.2 Test result

From the test result after adding the NVIC I2C and PORTA disable code, we can get the uart can works ok, if you have interest to test, the I2C will also work ok.
