An Interim report on connecting a USB3343 USB transceiver to the LPC4357 Microcontroller

This report describes the difficulties that the report's author has had in configuring the LPC4357 Microcontroller to work with Microchip's USB transceiver.

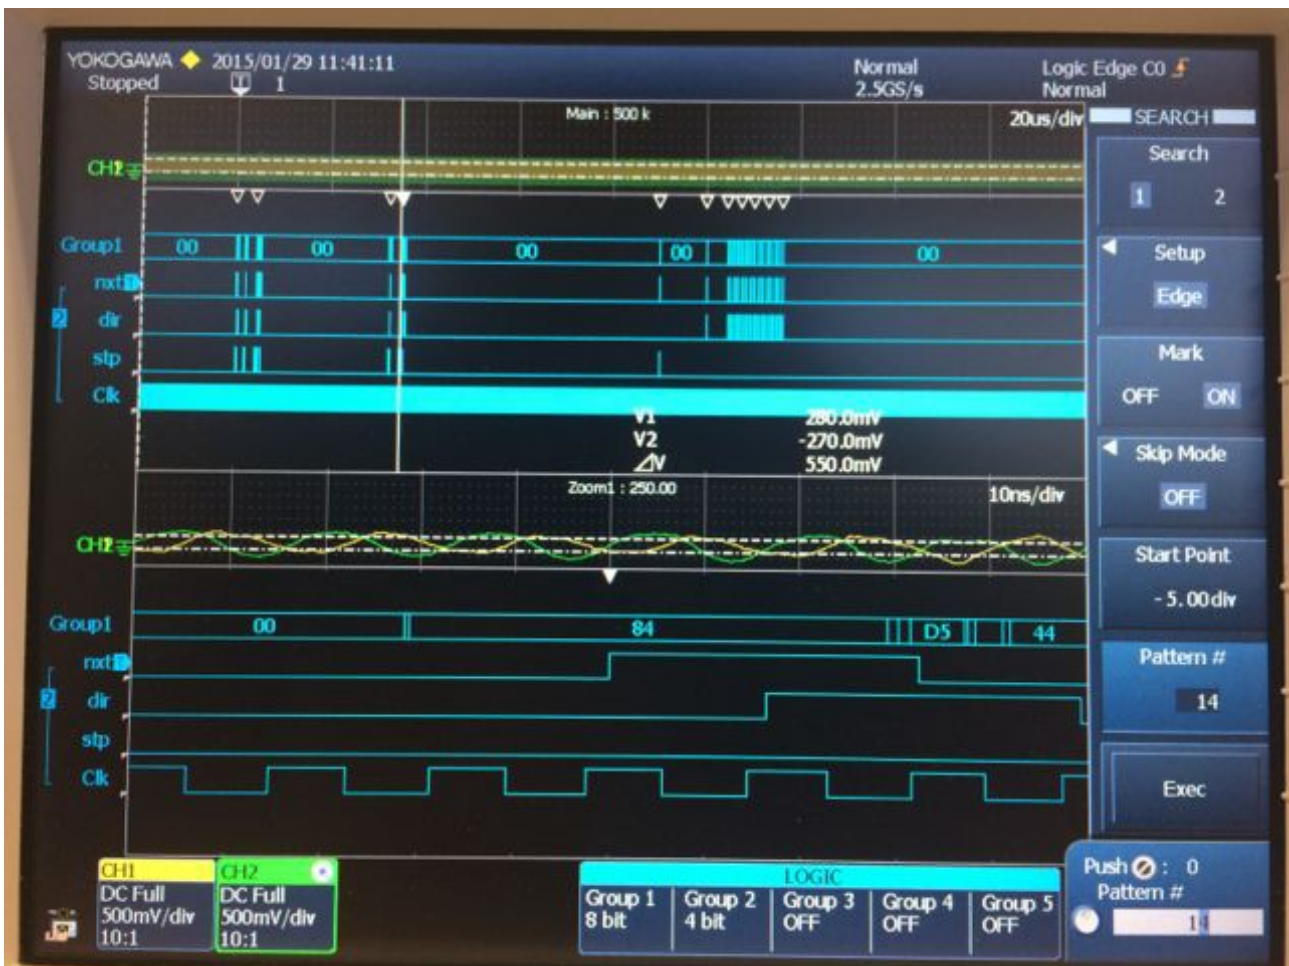
Figure 1: Anomalous 'dir' assertion

8B 0E	S	OTG Control	Pulldown on VBUS, Pull down on DM, Pull down on DP,
84 D5 (44)	W	Function Control	LPM Enable,!Suspend,!Reset,Disable BS&NRZI, TermSel=1, Xcvr=FS (#funky wave
84 51	W	Function Control	!LPM, !Suspend, !Reset, Disable BS&NRZI, TermSel=0, Xcvr=FS
89 07	C	Interface Control	!6pin serial,!3pin serial, !carkit (defaults)
88 08	S	Interface Control	Enable CLKOUT in Serial or CarKit mode
D3 10	R	USB Interrupt Status	IdGnd
D5 00	R	Debug	Line state = 00b
84 41	W	Function Control	!SuspendM, Normal Operation, Enable FS Xcvr
Action:			
LPC_USB1->USBMODE_D = 0x02 (1 << 3)			Setup Lockouts off Mode = DeviceMode
<i>no ULPI activity</i>			
Action:			
USBD_API->hw->Init()			
85 20	S	Function Control	Reset transceiver
8C 31	C	OTG Control	Do not drive VBUS, Disconnect resistor VBUS-VD33, Disable Pull up ID
8B 0E	S	OTG Control	Pulldown on VBUS, Pull down on DM, Pull down on DP
84 44	W	Function Control	!SuspendM, Normal Operation, Termination selected, Enable HS Xcvr

As noted adjacent to the '84 D5 (44)' command the waveform(Figure 1) during this Write command shows some anomaly with the 'dir' signal being asserted which would normally indicate a Read from the Phy register. In any case a normal looking write command follows immediately afterwards.

Pending advice from NXP or other parties I will manually configure the ULPI registers in the Phy setting the pull-ups and termination resistors into valid state and hope that the LPC's USB controller can be coaxed into life.
