ES_LPC4350/30/20/10 Rev A

Errata sheet LPC4350, LPC4330, LPC4320, LPC4310 Rev A
Rev. 1.2 — 1 February 2012

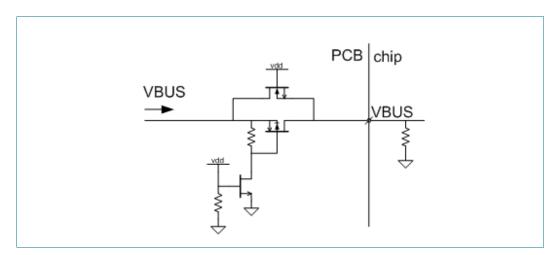
If USB0 or USB1 is used to implement a USB-powered USB device or OTG product, 5 V would be applied to the VBUS line on the LPC43x0 before the LPC43x0 was powered up. However, the VBUS line on the LPC43x0 5 V tolerant only when VDDIO is present.

For a simple USB device-only product, an external voltage divider is enough to prevent excess voltage from appearing on the VBUS line when USB is connected to an unpowered board. A schematic of a recommended voltage divider is shown below.
