Freescall AutoEVB-Board (Redboard S/N X00069)  
Using original MQX 4.0.2 BSP for AutoEVB and httpsrv-example

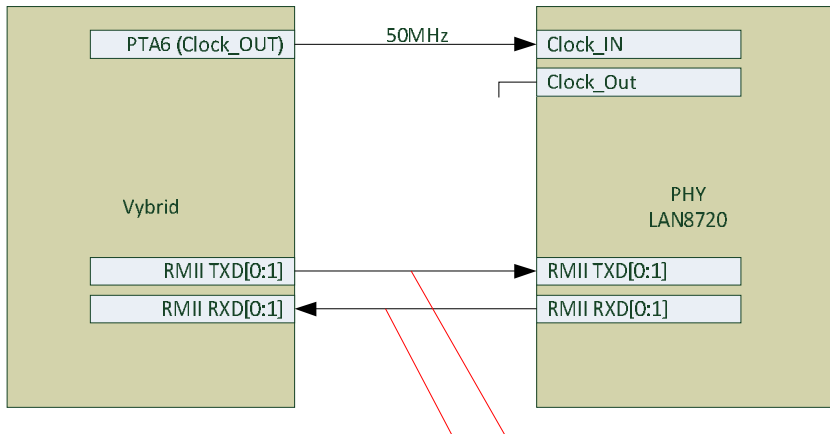
Does not working stable cause vybrid uses the wrong edge of the RMII-Clock to put data on his TX-lines.

Working fine

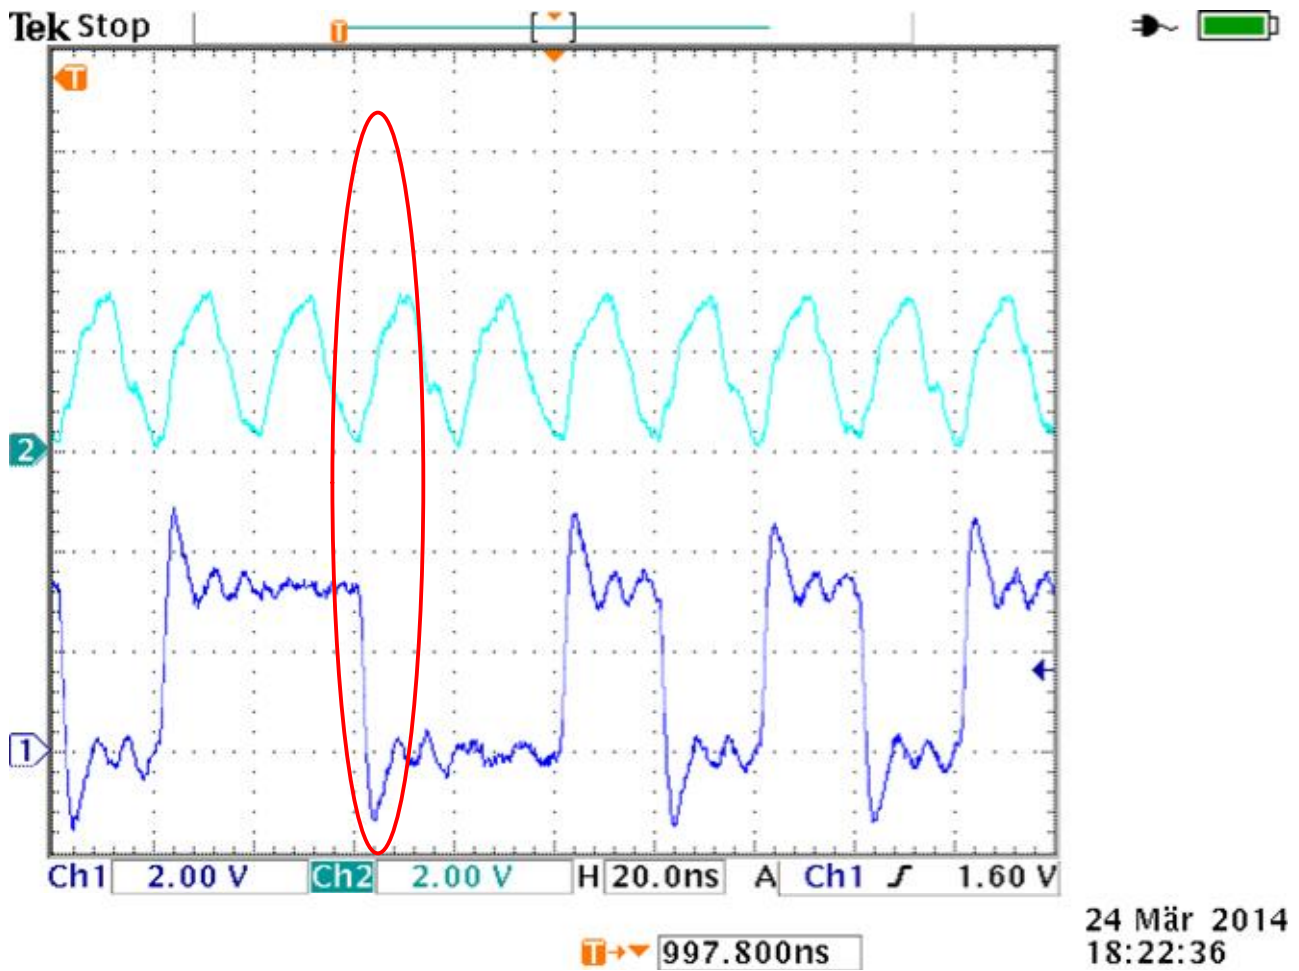
Is done using a freescale AutoEVB-Board and the original MQX 4.0.2 with httpsrv-example.  
Ethernet-Test : ping the AutoEVB-Board from a PC  
Test-Result : ping works fine

Problem : signal-waveforms are not very good. Especially the RMII-Clock.  
Cause : pad settings are not optimal (drive-strength)

Measure 1 – original settings freescale source-code - channel 2 RMII-Clock – channel 1 TXD1

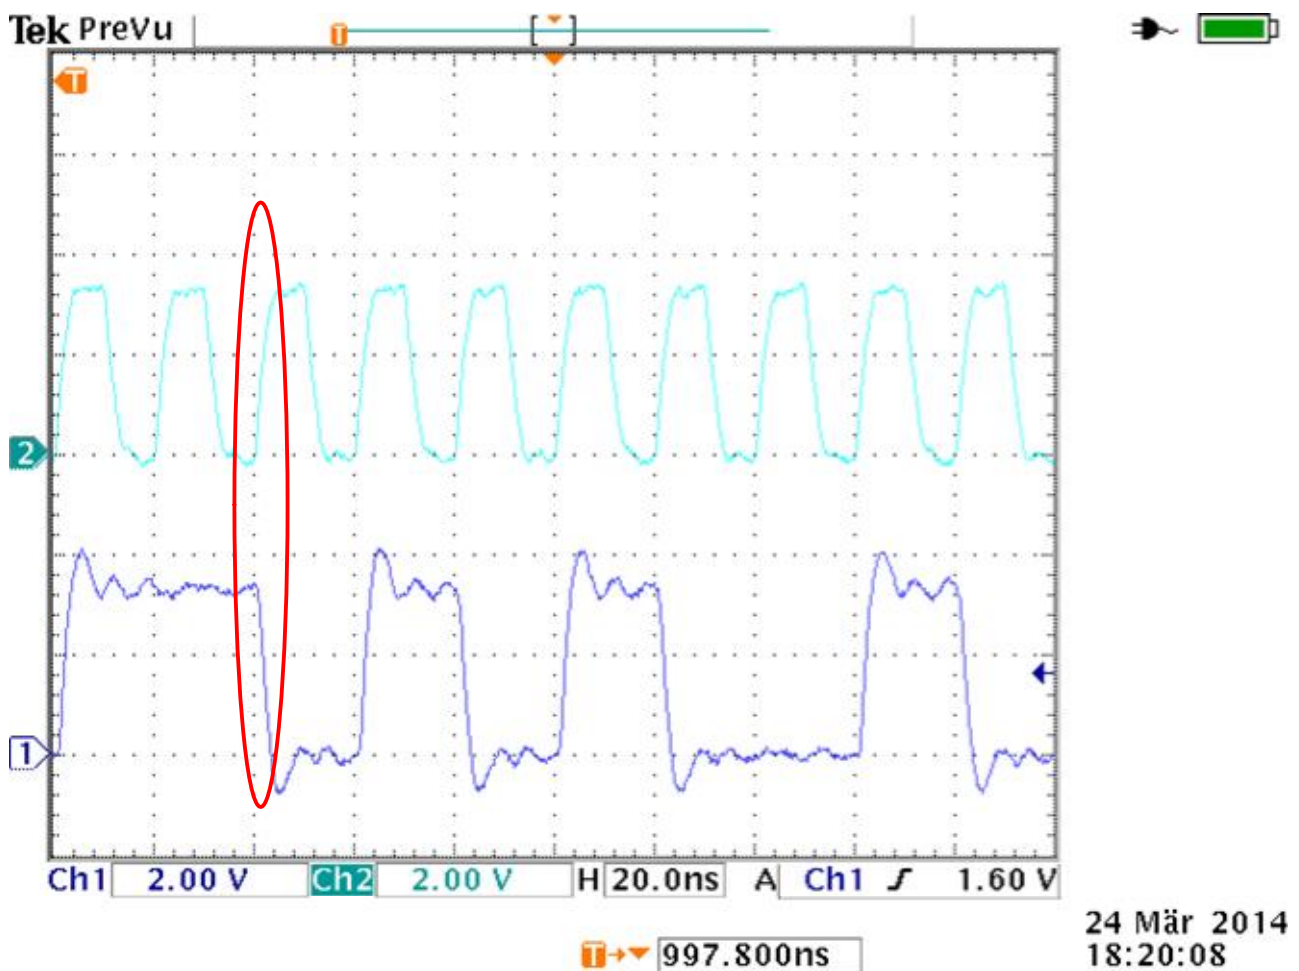
Same source-code as used in measure 1 expecting following pad-settings:  
PTA6 (RMII-Clockout : changed drive strength from 1250hm to 750hm an speed from 50MHz to 200MHz)  
TXD1 (changed drive strength from 20 Ohm to 500hm)

Ethernet-Test : ping the AutoEVB-Board from a PC  
Test-Result : **ping does not work**. Incoming ethernet-communication works fine. No outgoing ethernet-communication.

In my opinion there is a problem inside the vybrid-cpu. The vybrid-cpu puts data to the RMII-interface on the wrong edge of the RMII-Clock.

The original source-code from MQX only works, cause the pad-settings are wrong. The trigger-point is shifted a little bit to the right by the wrong settings. But it is not a stable solution.

Measure 2 – modified pad-settigs – channel 2 RMII-Clock – channel 1 TXD1
