MU Restore FW

1. Root cause

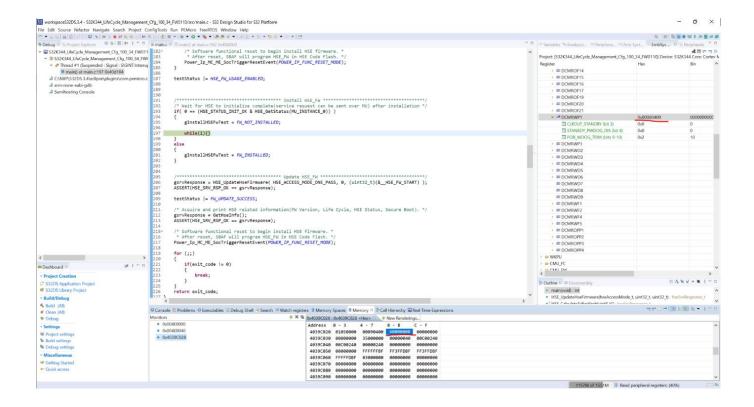
5.1 before start handshake

The bits 24-31 of DCMRWP1 register are all 0 by default, and bits 0-4 in 0x4039C028 are all 0 at this time, the FW Installation Process (MU) process is not started.

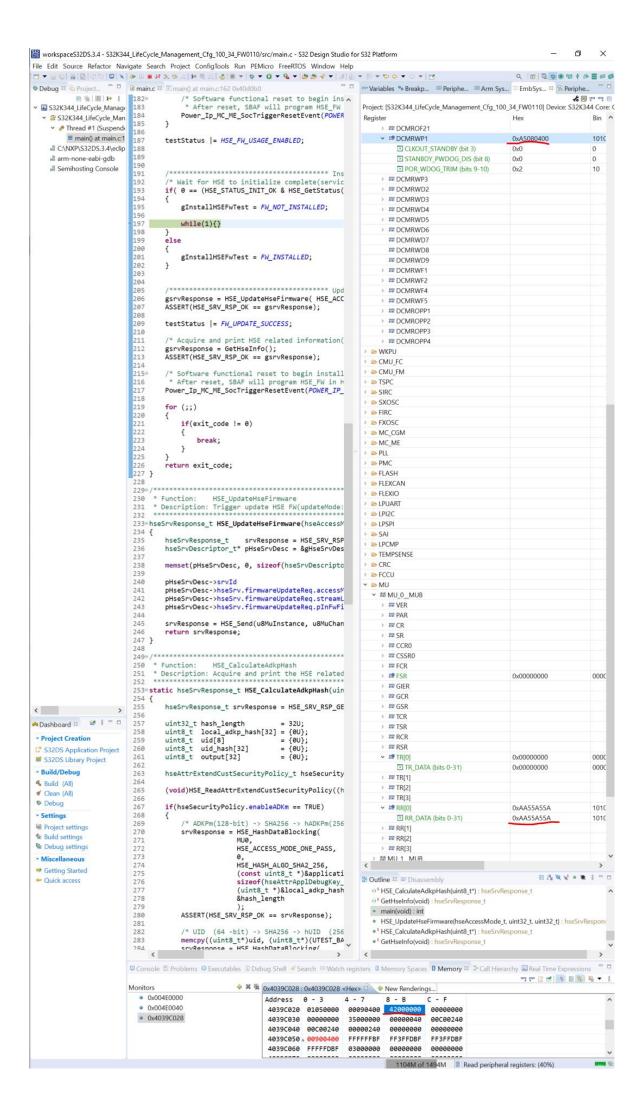
5.2 start handshake

Write A5 to bits 24-31 of DCMRWP1 register, click "run" and "stop", the HSE GPR 3 bit 1 assertion (MU interface is enabled for installation of HSE Firmware.),

Meanwhile, **HSE** sends 0xAA55A55A to **M7 core** via MU0-MUA TR0, and the value can be viewed via MU0-MUB RR0, at the value can see from debug window

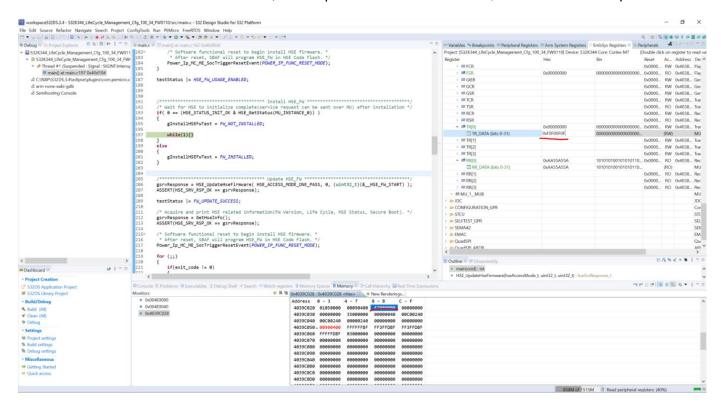
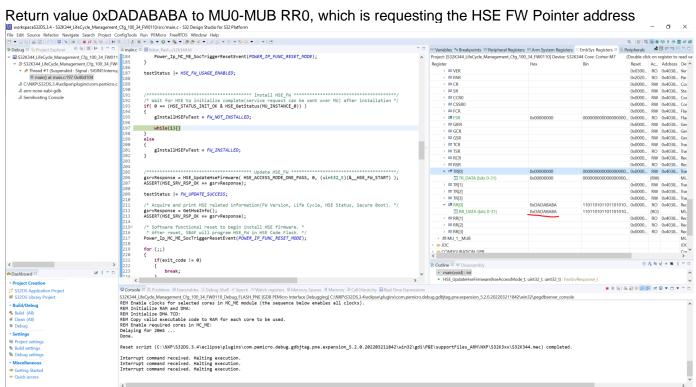
5.3 response

Send 0xF0F00F0F via MU0-MUB TR0, the response for the handshake, click "run" and "stop"

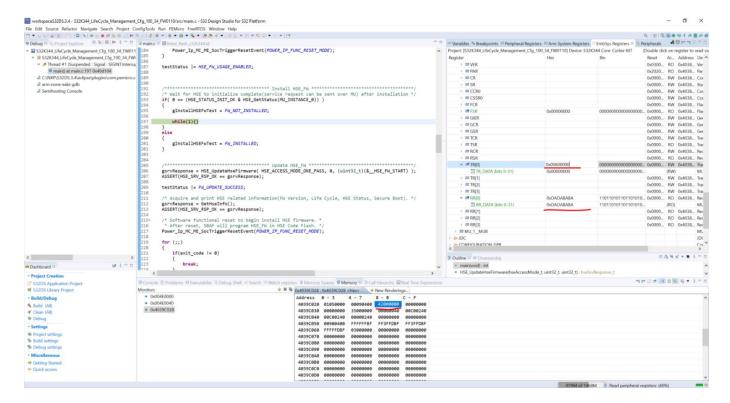
5.4 Provide the HSE FW pink image address

Provide the firmware address, in this pic is 0x00600000, users can fill in different values for the actual location of HSE FW without specific requirements, and then run the code.

After successful installation, RR0 returns 0xAA55A55A, means Valid HSE FW present in Passive Block

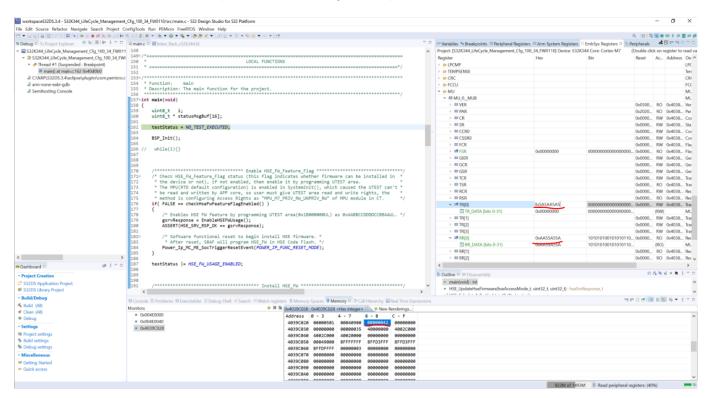
5.5 Switch partition

Send 0x5A5AA5A5 via TR0, request the Switching active/passive Block.

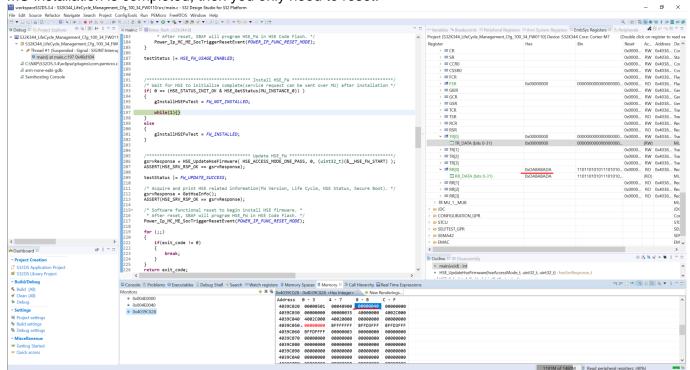
Can see that the switch is successful, RR0 returns 0xDABABADA, and clears the HSE GPR bit 1 as the MU installation is completed, then you only need to reset.

After reset, the MU FSR value is 0x09600000, the HSE GPR bit 0 is set to "1", HSE FW is present and SBAF Booted HSE Firmware.
