Workaround for programming 56F8323 in CodeWarrior v10.6 debugger

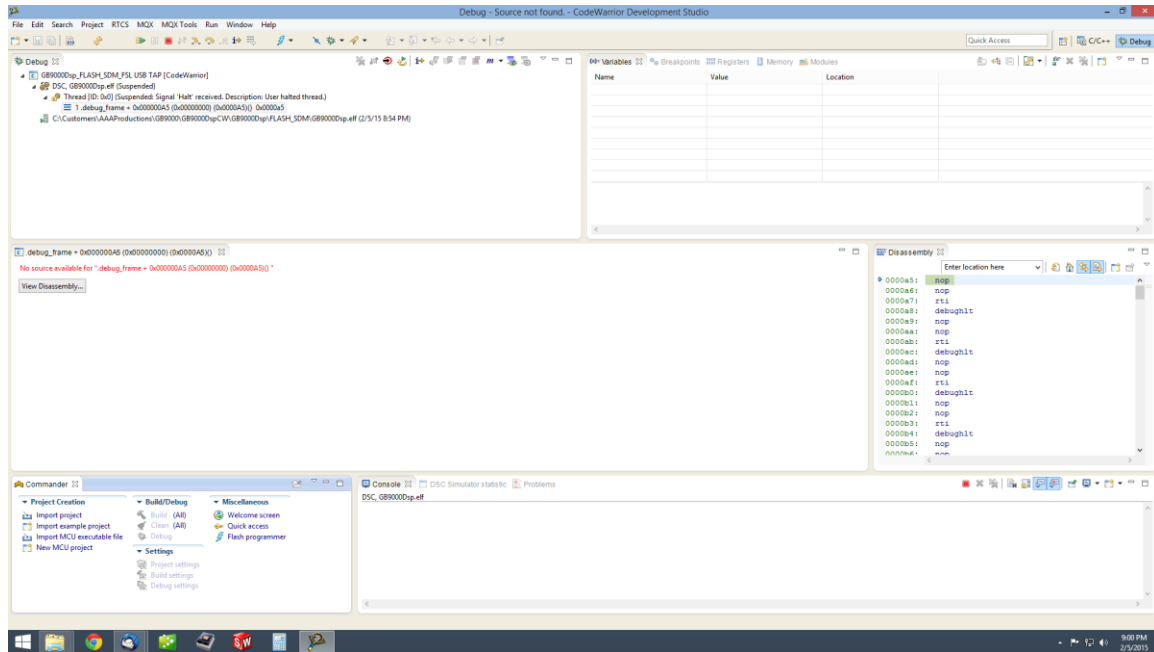
There is a known problem in CodeWarrior v10.6 debugger. After user creates a new bareboard project for 56F8323 in CW10.6 and starts debugging with USBTAP, but the debugger stops, and the debugger view shows "No source available for ".debug_frame + 0x000000A5 (0x00000000) (0x0000A5)()", just as below:

To resolve this problem, we need two steps:

- 1) Go to project folder, and open the file "MC56F8323.tcl" under "\Project_Settings\Debugger" subfolder, then add the line as below between "change x:0xF401 0x0000" and "change x:0xF401 0x0100" to unprotect boot sector:

change x:0xF411 0x0000

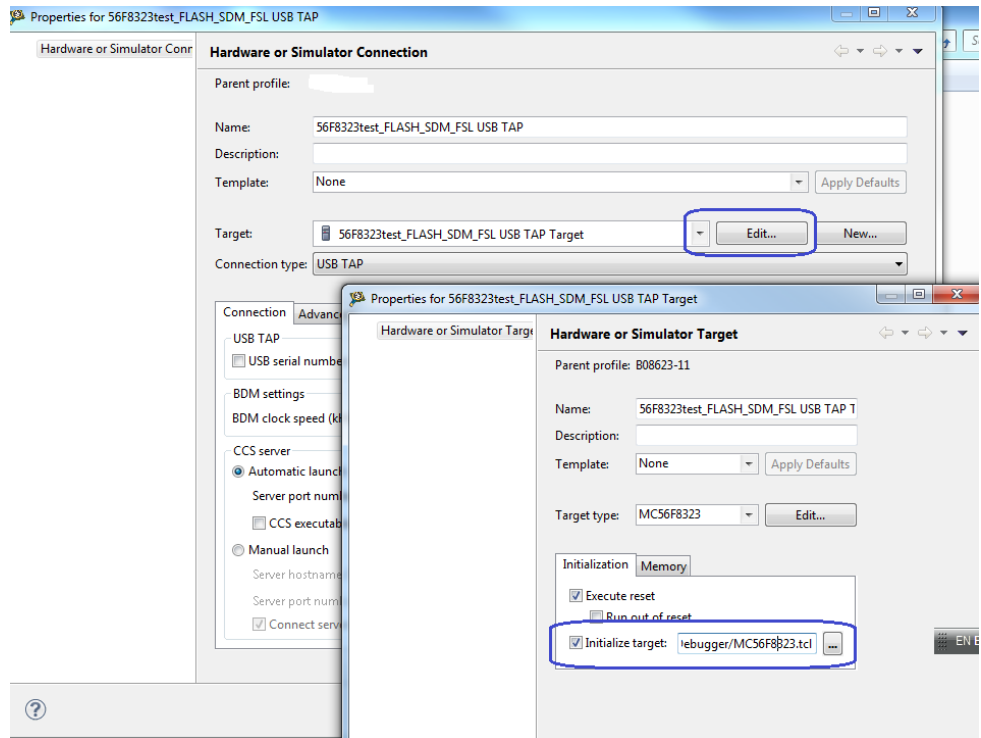
Because this file is copied into the project subfolder ("Project_Settings\Debugger") when user creates a new project for DSC from File menu->New->Barebaord project. User can find the path which saves the copied file as below:

It is recommended to make this modification in "MC56F8323.tcl" either which is under the CodeWarrior folder:

C:\Freescale\CW MCU v10.6\MCU\lib\wizard_data\DSC\DataBase\init_files
