The Analysis Report USB-TAP cannot workable problem

Issue date: 2010/10/13

Report date: 2010/12/13

Problem description: There is a few USB-TAP cannot workable in COP RDB

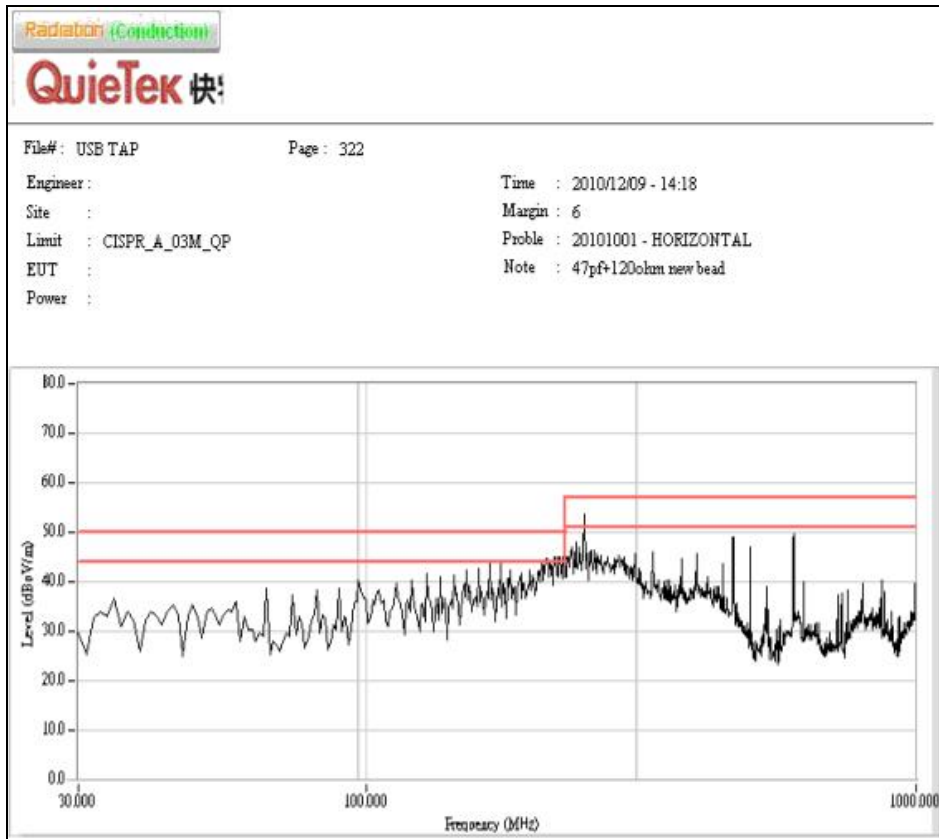
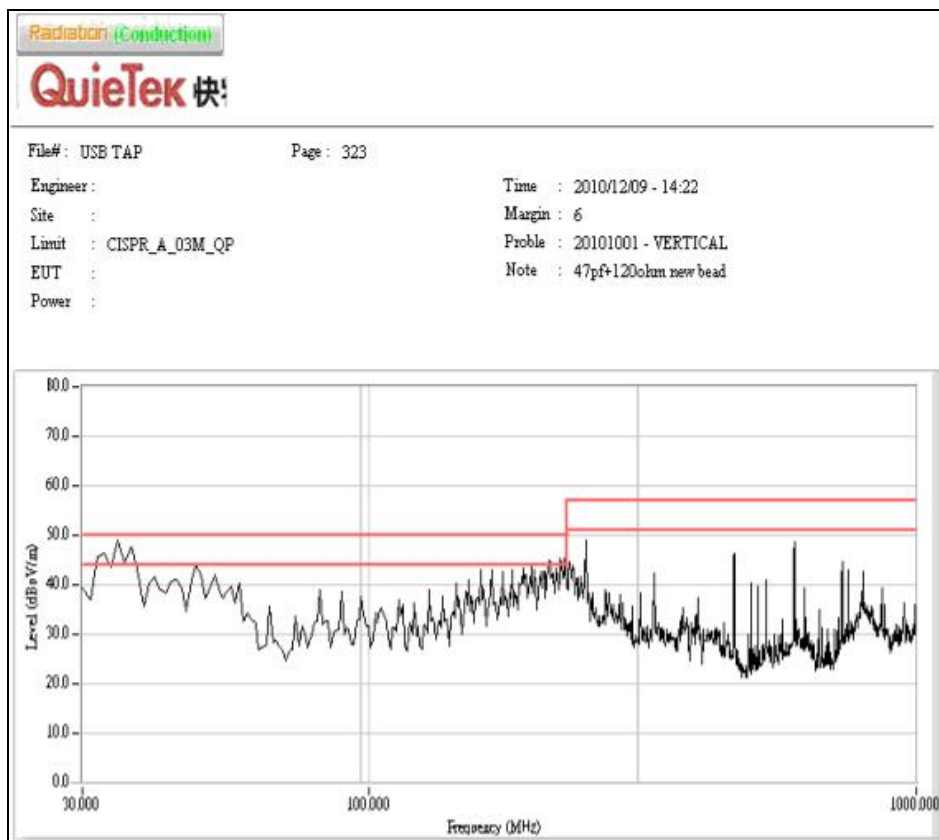
Root cause: It's a timing margin issue.

The EMI decoupling capacitor C118 (0.1uF) is too large to slowdown the falling time of TCK (JTAG signal). It makes the setup and hold time over IEEE1149.1 specification.

3. NEW USB-TAP (REV.D), C118 stuff 0.1uF

JTAG timing: $t_{JTAGR}=6ns$, $t_{JTAGF}=11ns$ over spec $2ns$ (note: probe Tek 116526 has lag)

JTAG Functionality: Some models are fail

EMI in CE/FCC: PASS
