i.MX6Solo ESAI TDM slot issue (1/)

- Overview
 - The TX output data slot location could be misaligned when ESAI_TX(RX)_CLK frequency is higher than 20.8MHz.
- The customer's setting
 - The customer's system is as Figure-1.

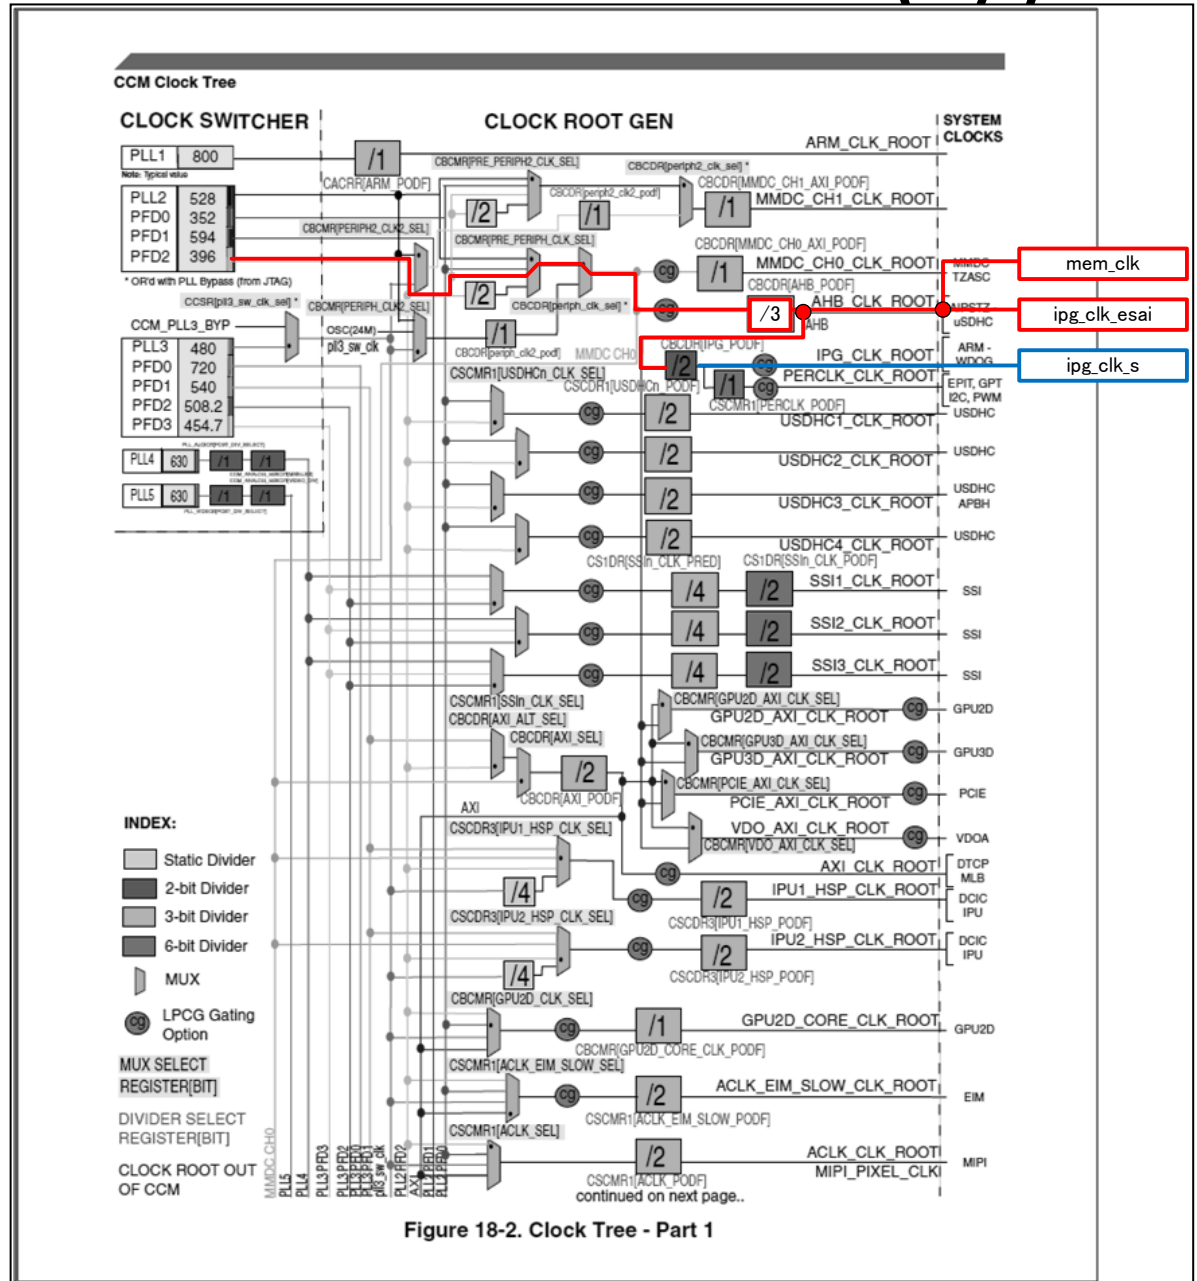
Figure-4-1 clock tree setting

- Direction settings for each clocks: Input
 - Frame Sync Length(TCR-TFSL) setting: Word Length
 - Sync setting(SAICR-SYN): ASYNC
 - Internal clock settings for the clock to be sent to ESAI: Default (Figure-3, Figure-4-1, Figure-4-2)
