How to Change i.MX8MM evk Linux Debug UART

Biyong SUN
11, MAR 2021

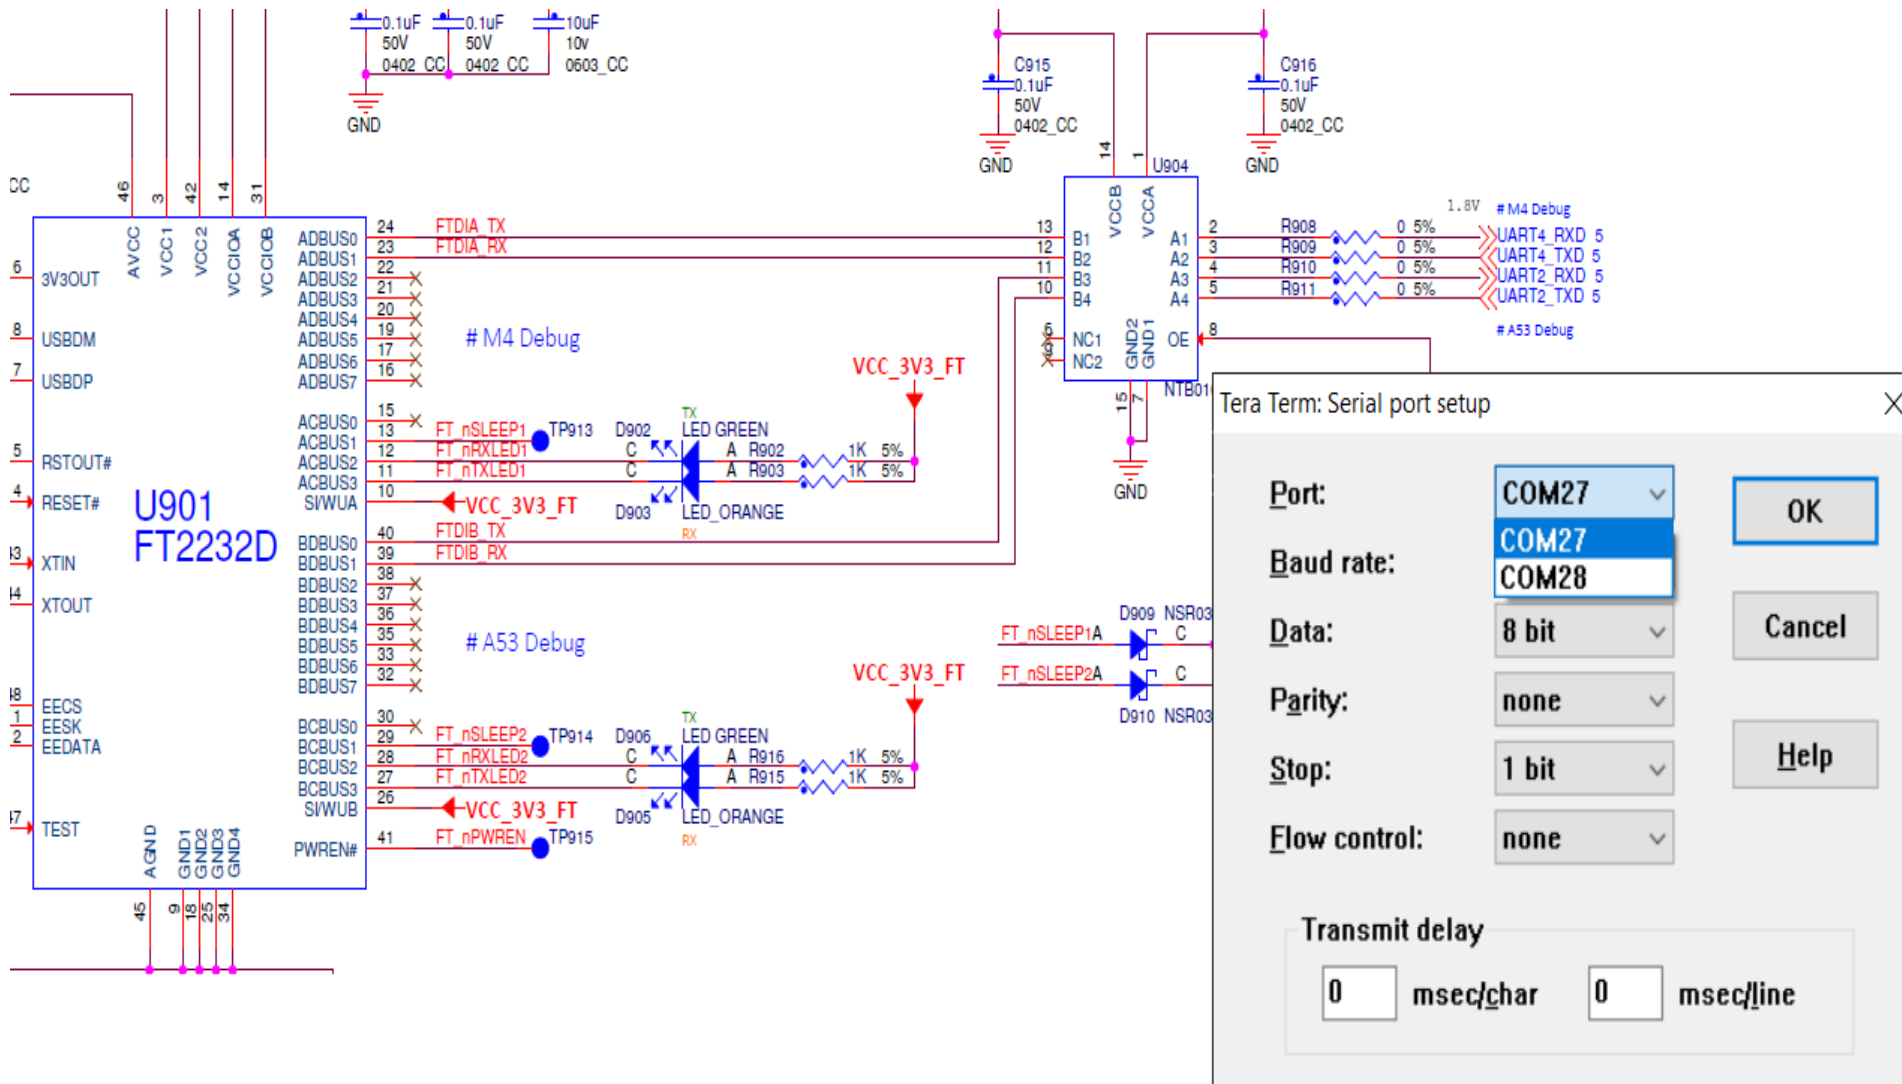
Debug UART on i.MX8MM EVK board

Two debug UARTs
on i.MX8MM EVK

UART2 --- A53
UART4 --- M4

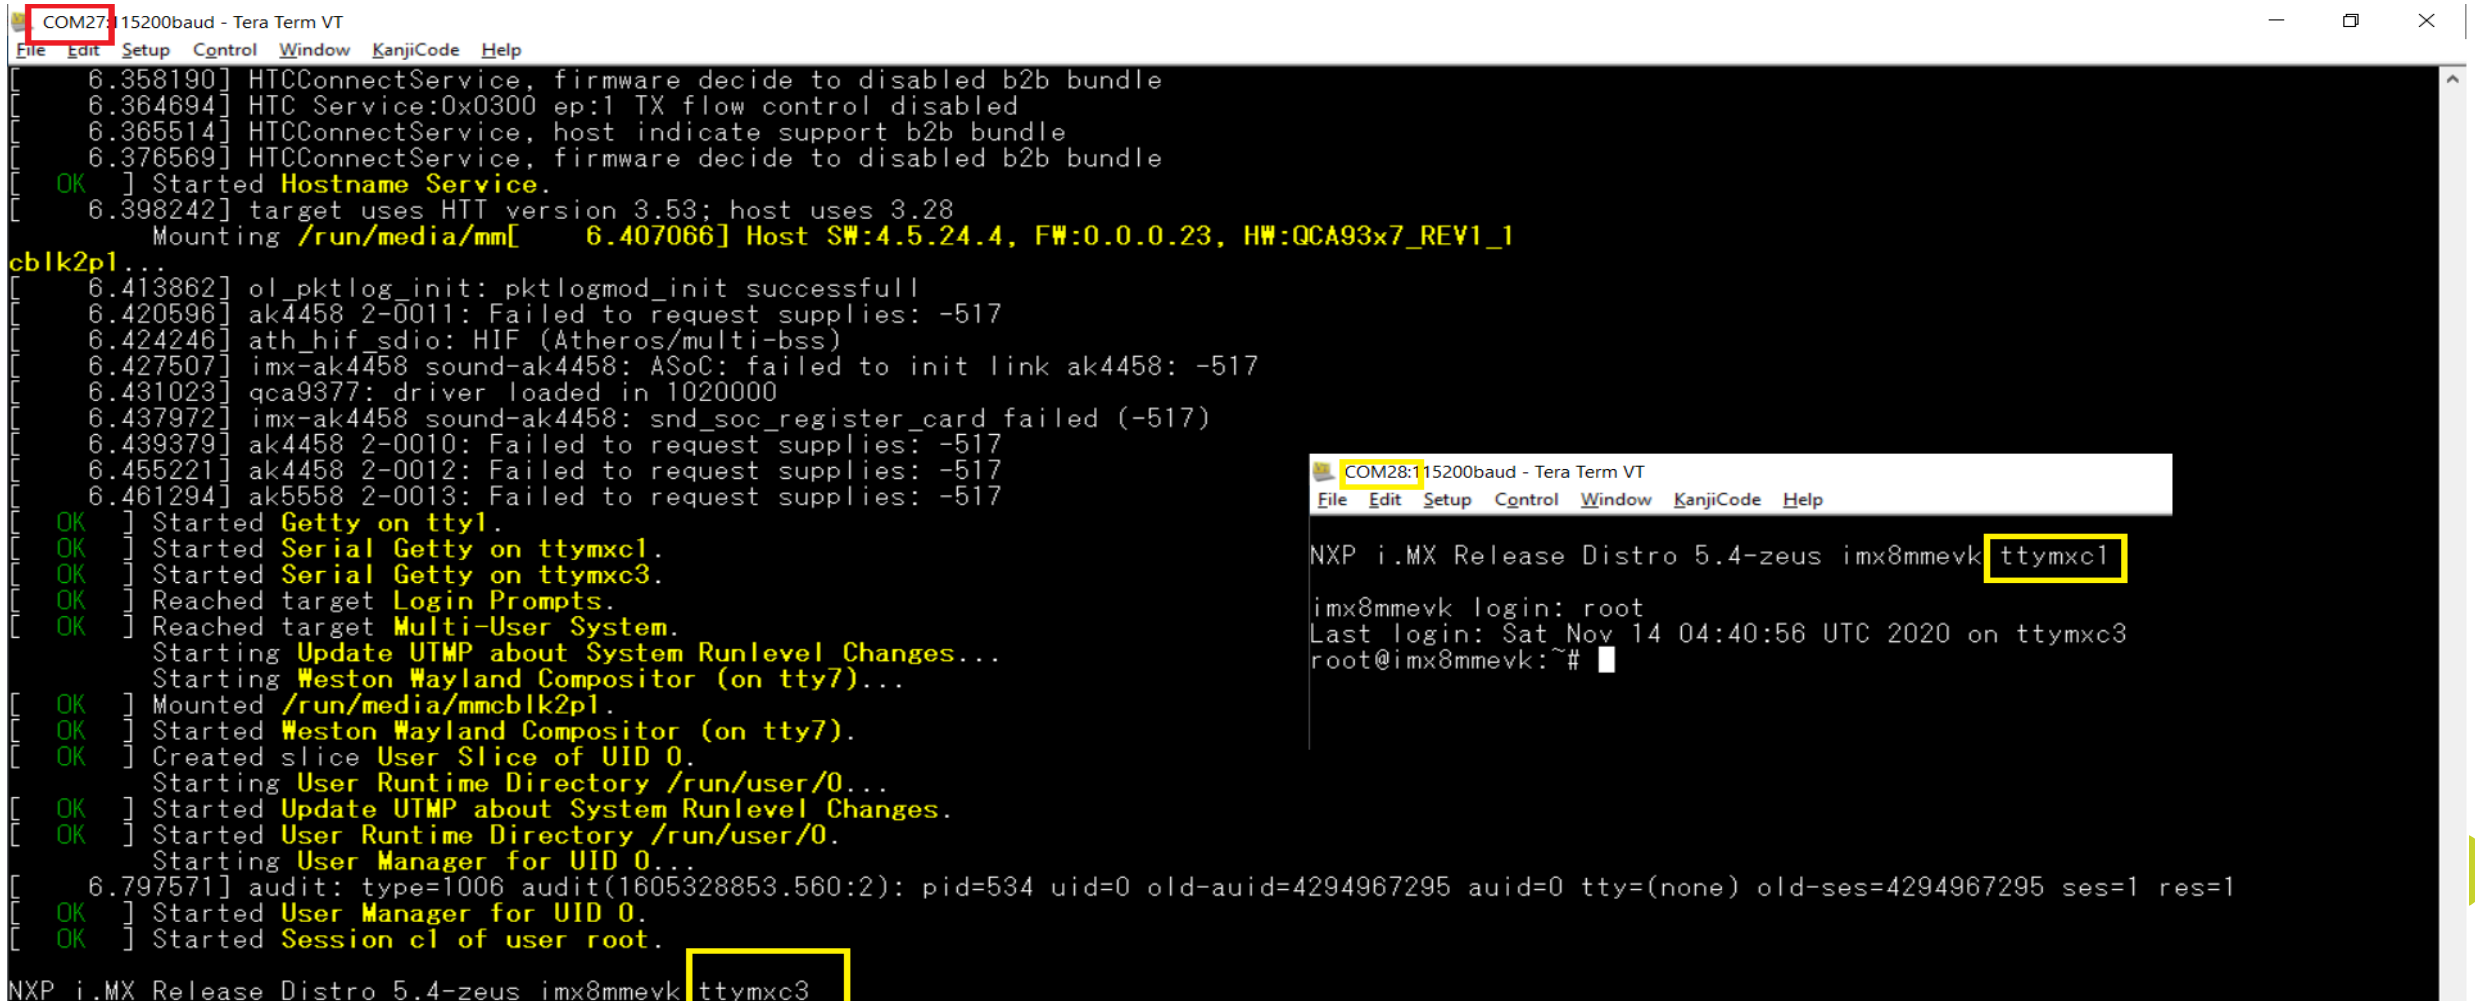
Test UART4(ttymxc3)

The ttymxc3 is debug uart4, so it has kernel debug output.
But ttymxc1 is not debug uart anymore, it just for user login.

The image shows two terminal windows. The top window, titled 'COM27:115200baud - Tera Term VT', displays a detailed boot log. It shows the system starting services like Hostname Service, mounting media, and initializing various hardware components. The log ends with the system reaching the 'Multi-User System' state and starting the User Manager for UID 0. The bottom window, titled 'COM28:115200baud - Tera Term VT', shows the login prompt for 'ttymxc1'. The user 'root' logs in, and the prompt changes to 'root@imx8mmevk:~#'. The top window also shows a similar login prompt for 'ttymxc3' at the bottom.

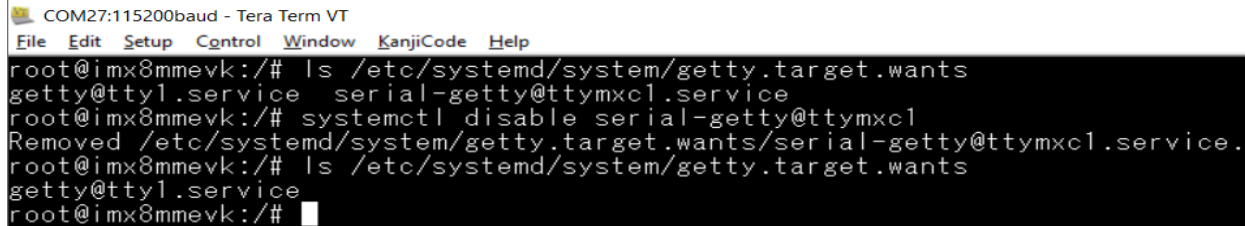
Disable UART2(ttymxc1) for application to use

systemctl disable serial-getty@ttymxc1

A terminal window titled "COM27:115200baud - Tera Term VT" with a menu bar containing "File", "Edit", "Setup", "Control", "Window", "KanjiCode", and "Help". The terminal shows the following commands and output:

```
root@imx8mmevk:/# ls /etc/systemd/system/getty.target.wants
getty@tty1.service  serial-getty@ttymxc1.service
root@imx8mmevk:/# systemctl disable serial-getty@ttymxc1
Removed /etc/systemd/system/getty.target.wants/serial-getty@ttymxc1.service.
root@imx8mmevk:/# ls /etc/systemd/system/getty.target.wants
getty@tty1.service
root@imx8mmevk:/#
```
