1 Introduction

The intention of this application note is to describe how the ECC protection is implemented with the MPC5744P device and to understand the MCU's ECC event response.

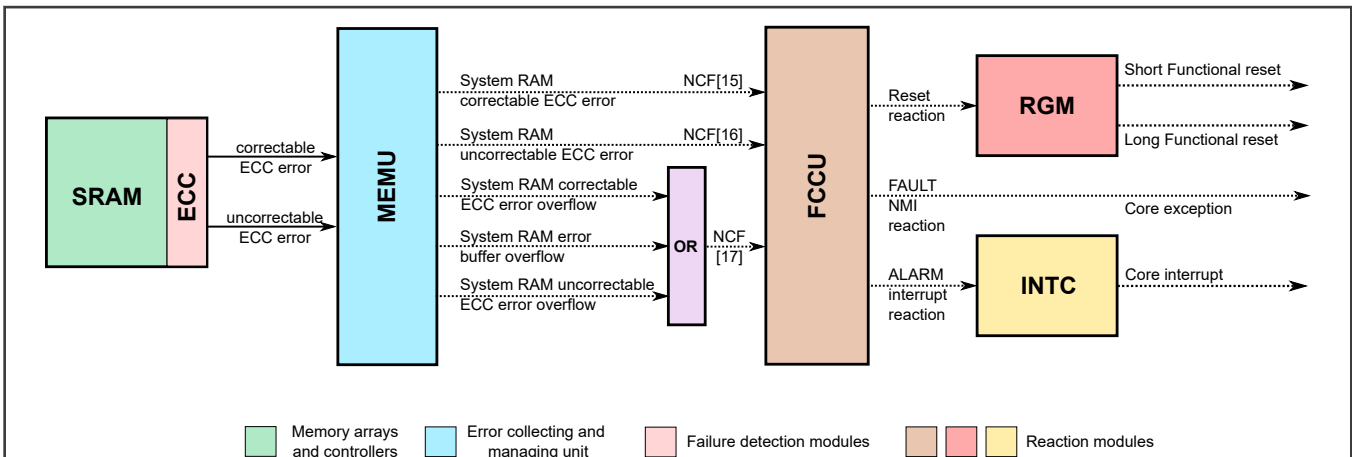
Figure 3. MPC5744P's SRAM ECC error reporting path

- If the reporting table entries are full and a new unique error is reported by the system, the "ECC error overflow" signal can be indicated to the FCCU. If it cannot process all simultaneously-arriving reports (because it aggregates address information from several sources), the "buffer overflow" signal is signaled to the FCCU with a dedicated fault for every instance. [Figure 3](#), [Figure 4](#), and [Figure 5](#) show the ECC error-reporting paths.

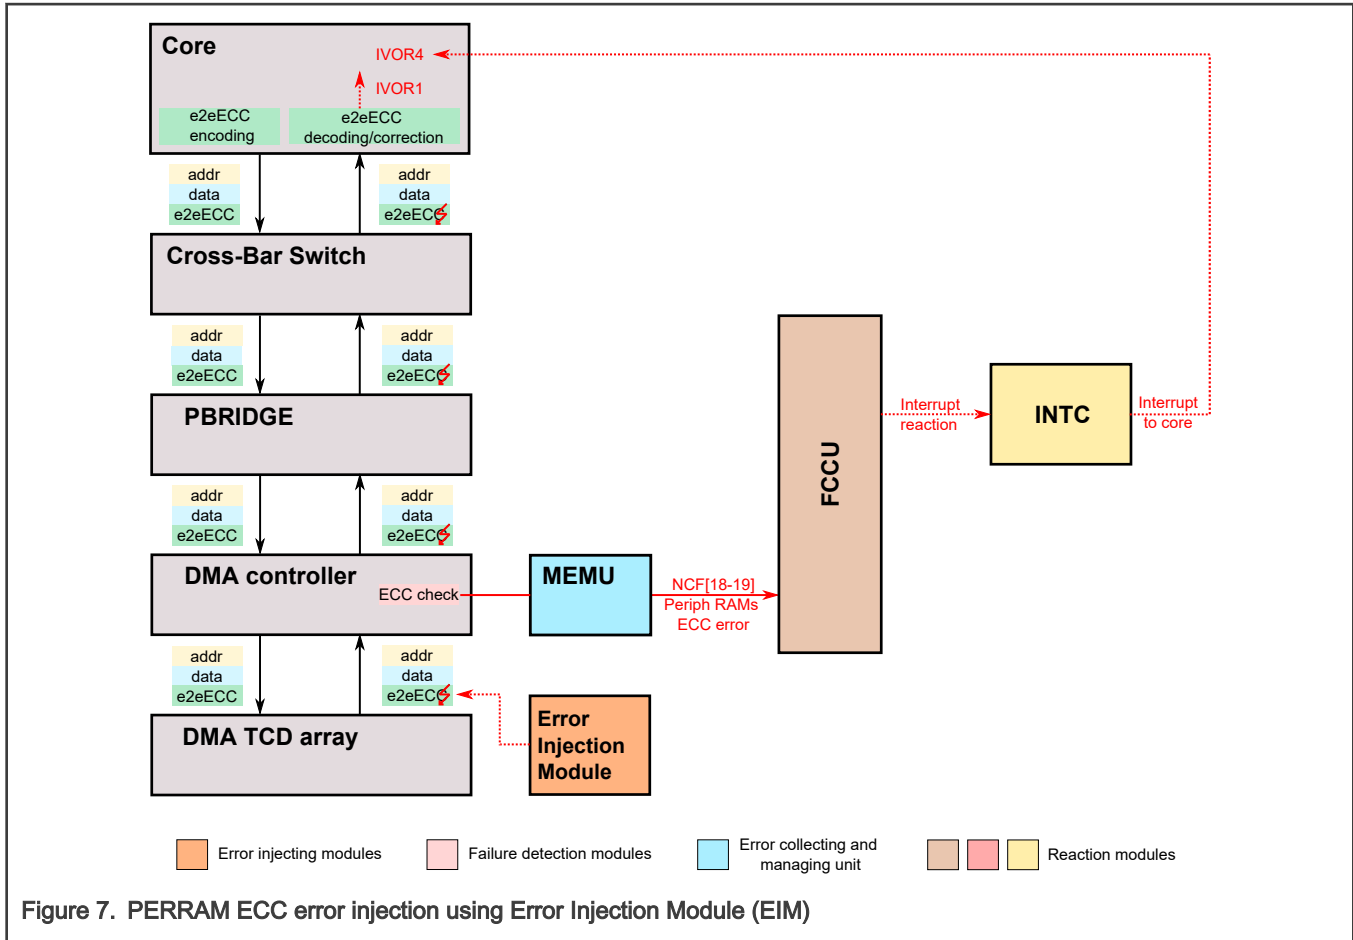
Figure 7. PERRAM ECC error injection using Error Injection Module (EIM)

The ECC error in the DMA RAM memory can be simulated using the Error Injection Module (EIM) on the MPC5744P device. EIM can simulate the single-bit and multi-bit errors by inverting the selected lines on the data/checkbit bus of the DMA RAM memory during a read operation.

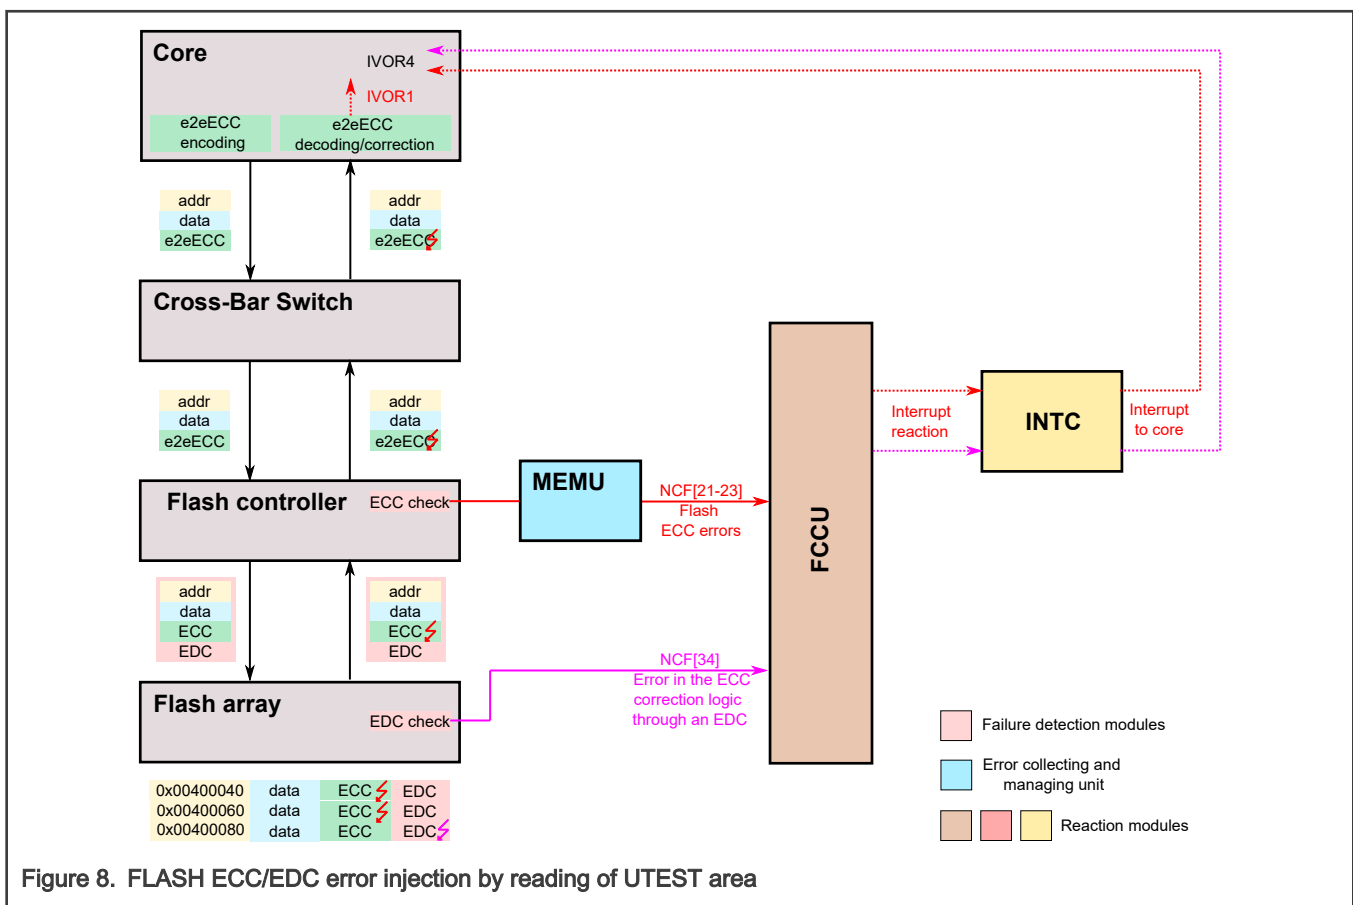
Start address	End address	Size (bytes)	Description	Notes
0x00400040	0x0040005F	32	Customer single-bit correction area	*
0x00400060	0x0040007F	32	Customer double-bit detection area	*
0x00400080	0x0040009F	32	Customer EDC after ECC area	*

* Programmed by NXP to include ECC/EDC errors to allow testing of ECC/EDC hardware
