Error Correction Codes Implemented on MPC5777C or MPC5775B/E

The intention of this application note is to describe how the ECC protection is implemented with the MPC5777C or MPC5775B/E device and to understand the MCU's ECC event response.

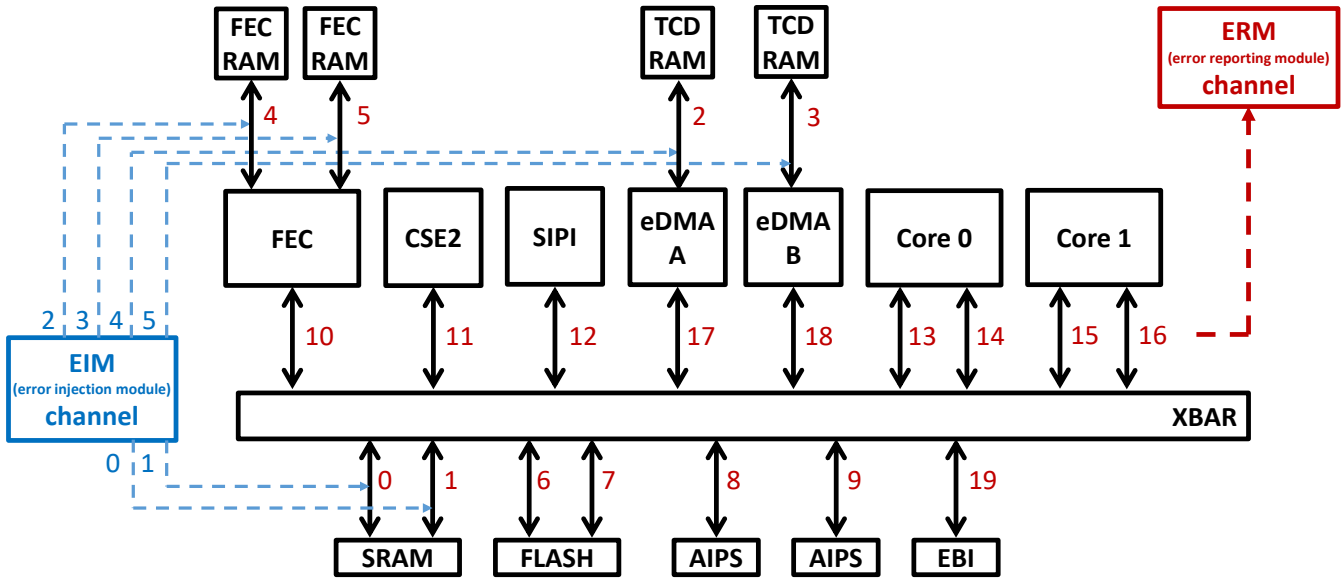
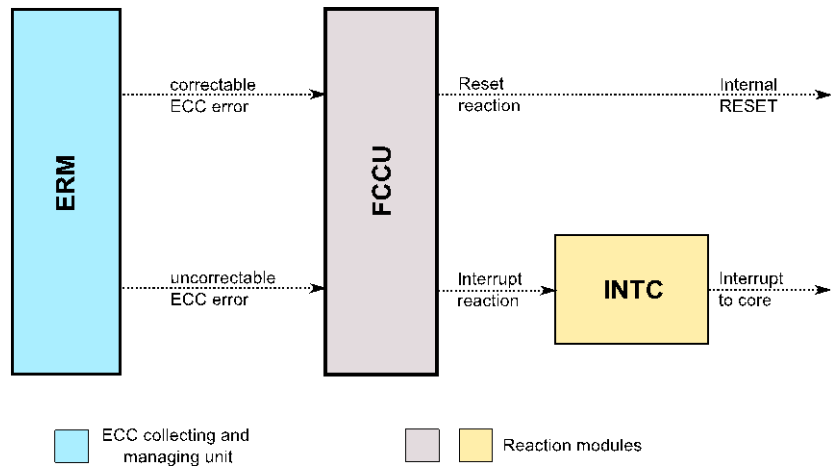
Figure 1. MPC5777C's ECC error reporting path

8.2.1. ERM

Error reporting module

8.2.2. FCCU

The non-correctable (multi-bit) ECC error causes the Machine Check Exception (IVOR1) and a potential interrupt generated via ERM-related FCCU non-critical fault input and its ALARM state (IVOR4 for the software vector mode or vector 488 for the hardware vector mode) or ERM interrupt.

If ECC non-correctable errors caused by other master than the core are supposed to be serviced, use the handling based on the ERM interrupt (Interrupt handling of non-correctable ECC error) or a combination of both approaches.
