The demo model is PNEV5190BP build the environment

1.After download the FW,neither the FSDI_8.bin or FSDI_10.bin

2.When i open the NXP NFC Cockpit v6.5.0.0,the warning pollup as follo picture

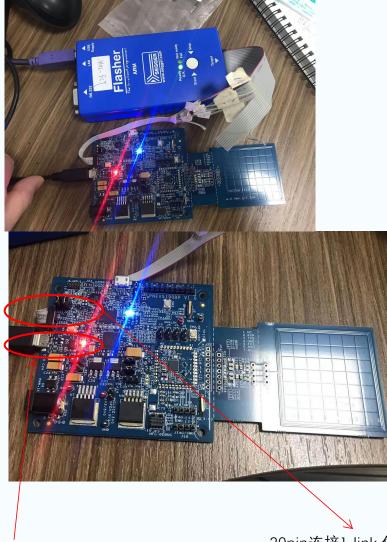
USB转Mirco连接电 脑 20pin连接J-link 仿真器

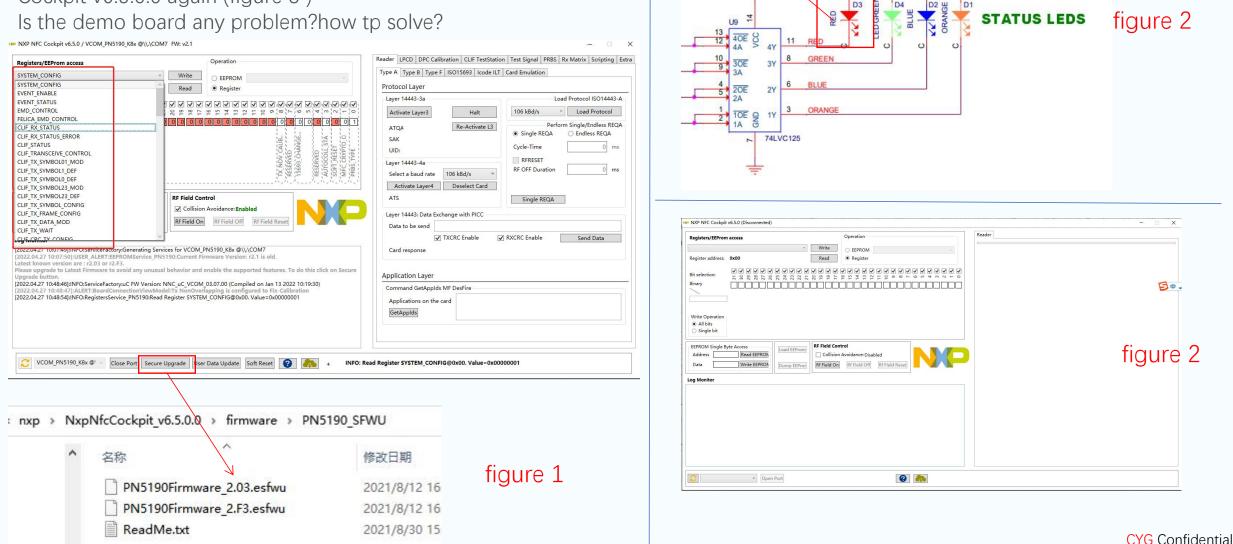
6.Mention a problem.after use the Secure Upgrade the file pn5190_2.03.esfwu and pn5190_2.F3.esfwu (figure 1) The LED D3 is flashing(figure 2) ,and i can't connect the Cockpit v6.5.0.0 again (figure 3)
